Infrared Inspection Report

MV Horizon Trader

RE: INFRARED ELECTRICAL SYSTEM SURVEY REPORT
OUR JOB NUMBER: 20-1234.7

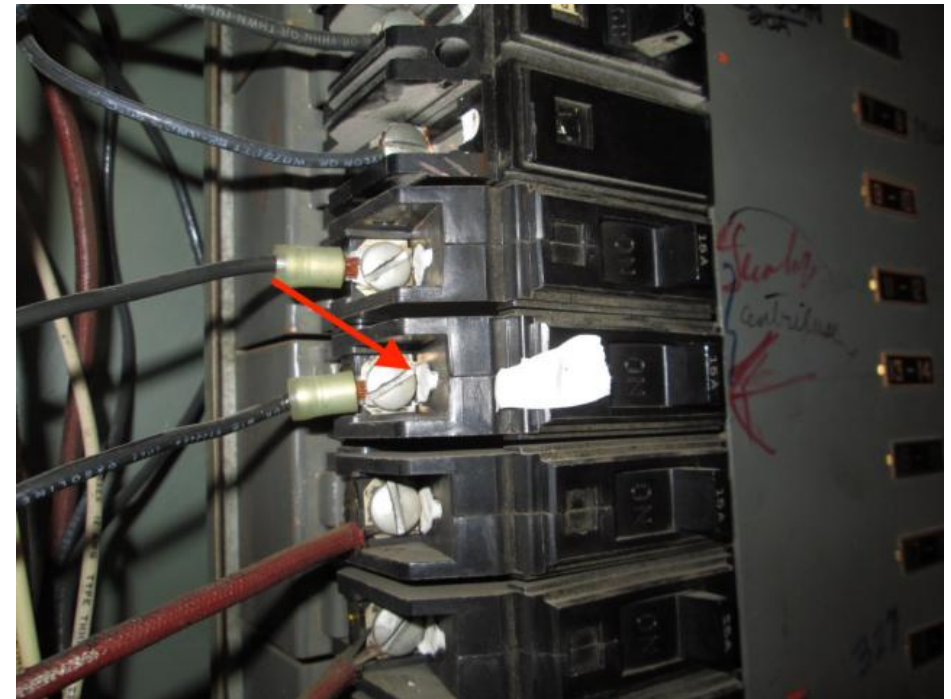
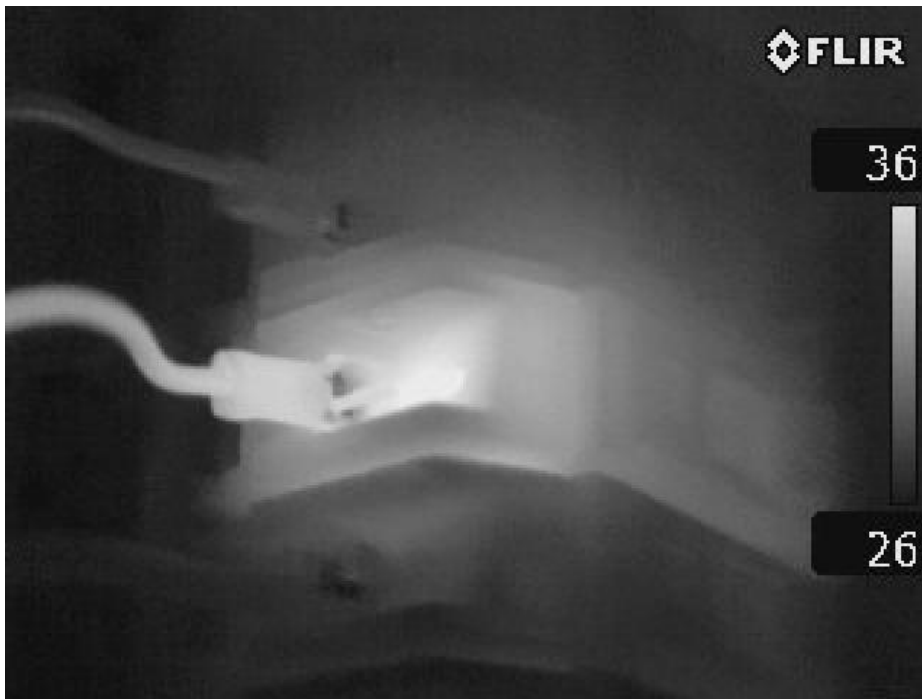
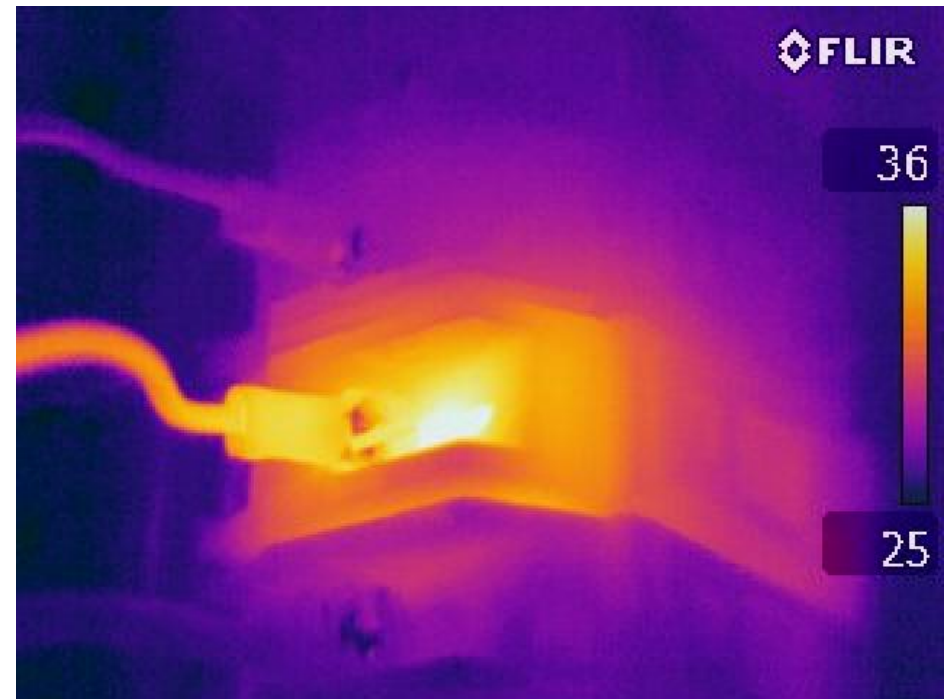
Area/Image No. 1 Job No. 1234.7 Date 12/10/2021 Time 08:53

Location 3rd Deck Equip # Break #13 Equipment Port Side Panel

Load: Rated 15 Amps Measured 7 Amps % 46.67%

Ambient Temp 26 °C ΔT 9.00 above Other Connections

Comments Conductor Connection temperatures:

Left
Upper	27°C
Middle	36°C
Lower	27°C

Obj. Priority 2 Subj. Priority Avg. Priority: 2

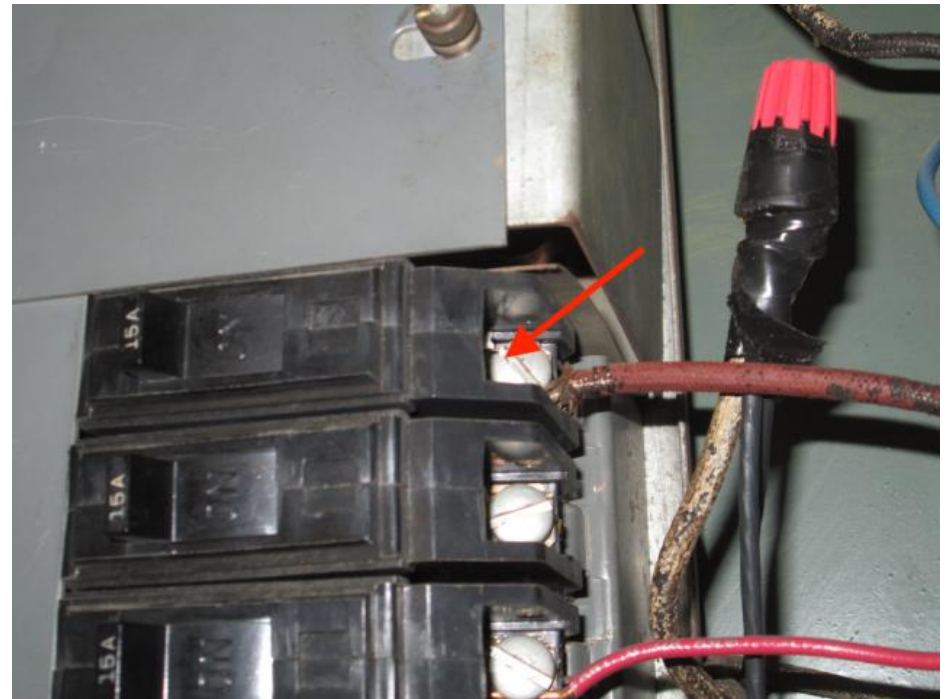
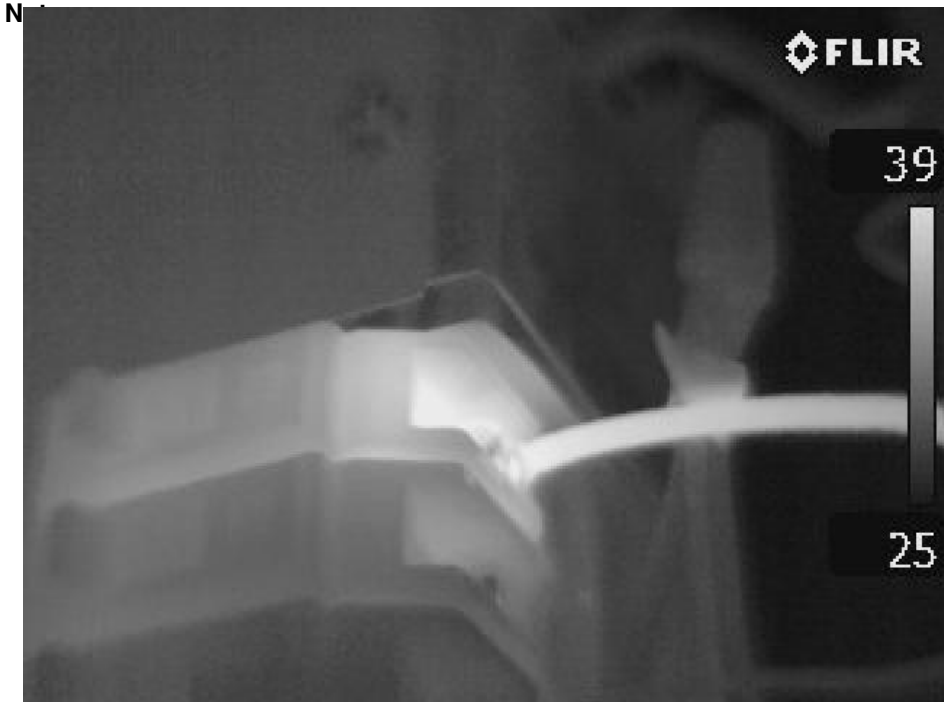
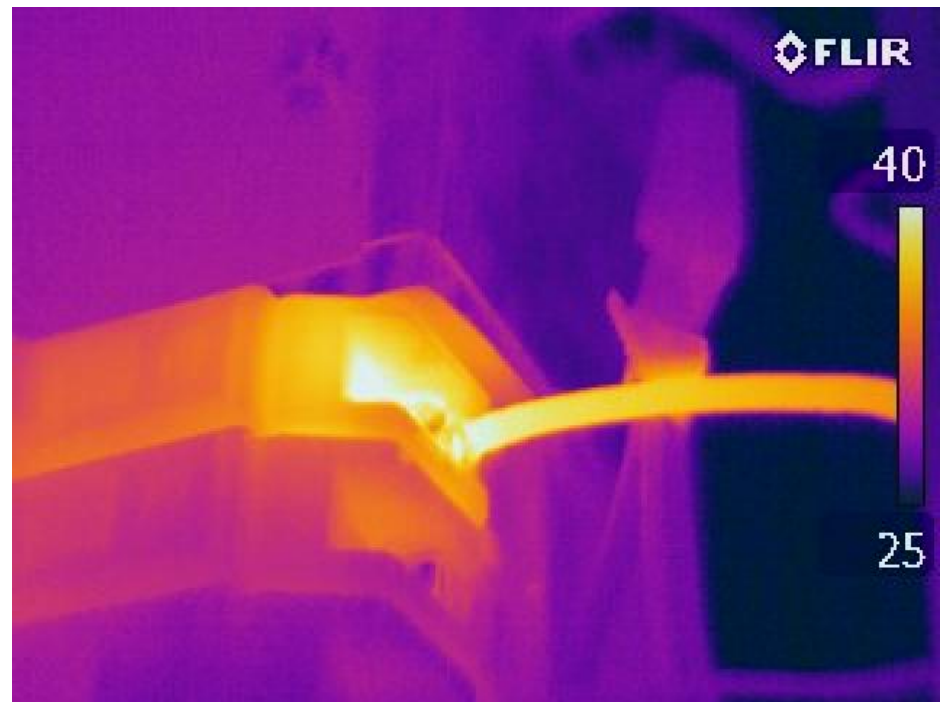
Area/Image No. 2 Job No. 1234.7 Date 12/10/2021 Time 09:10

Location 3rd Deck Equip # Breaker #2

Equipment Panel Outside Room 310

Load: Rated 15 Amps Measured 10 Amps % 66.67%

Ambient Temp 26 °C ΔT 15.00 above Lower Connection

Comments Conductor Connection temperatures:

Right
Upper	41°C
Middle	27°C
Lower	26°C

Obj. Priority 2 Subj. Priority Avg. Priority: 2

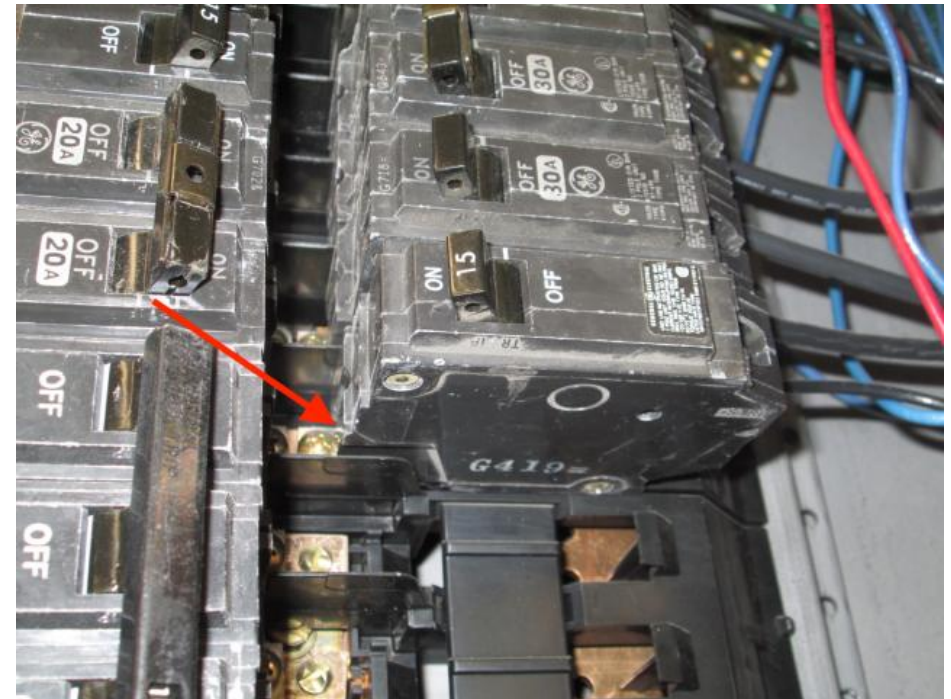
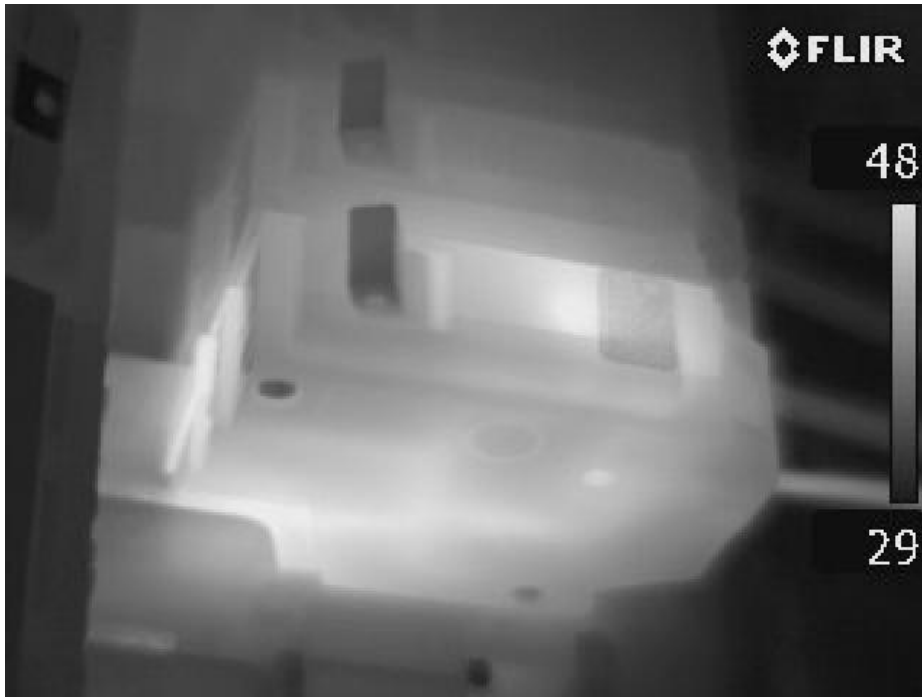
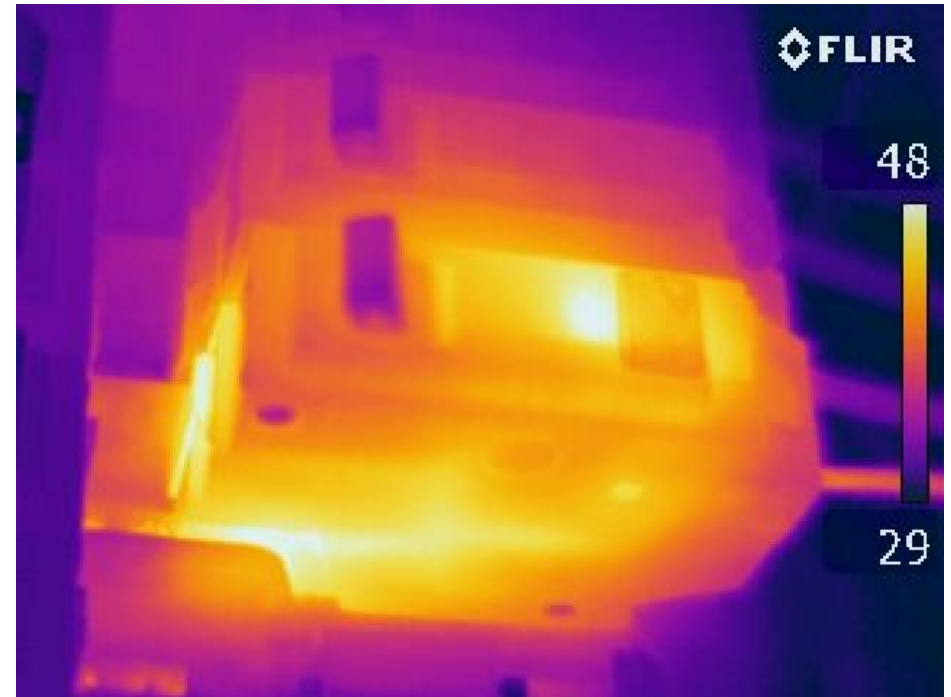
Area/Image No. 3 Job No. 1234.7 Date 12/10/2021 Time 09:10

It should be noted that the problems described in picture number 3 has an extremely high temperature differentials. This problem requires immediate attention.

Location 2nd Deck Equip # Breaker #24

Equipment Port Side Panel

Load: Rated 15 Amps Measured 11 Amps % 73.33%

Ambient Temp 30 °C ΔT 20.00 above Lower Left Connection

Comments Conductor Connection temperatures:

Left	Right
Lower	31°C	51°C

Obj. Priority 1 Subj. Priority Avg. Priority: 1

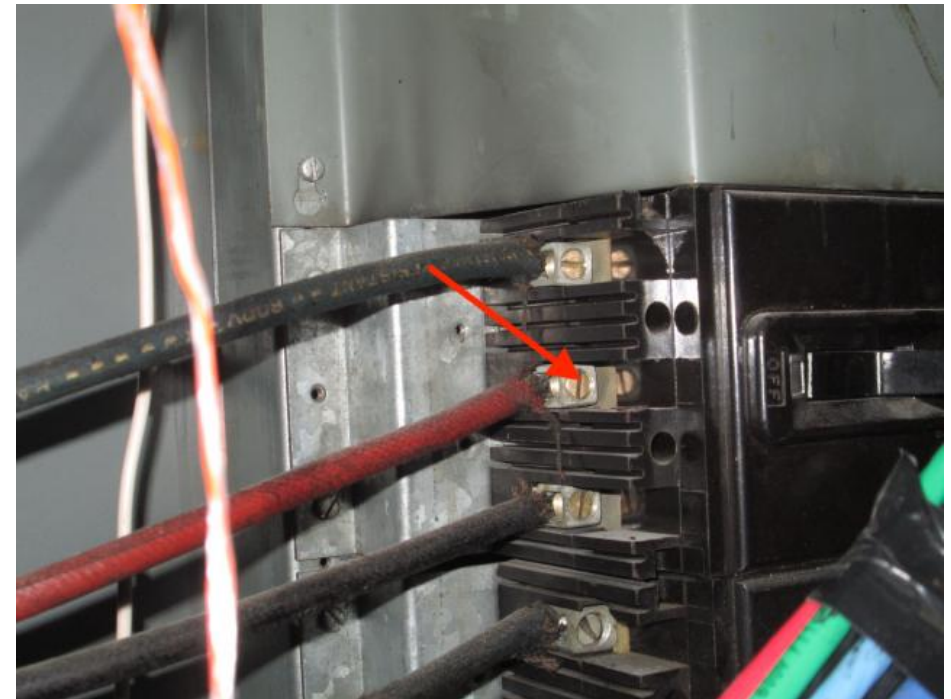
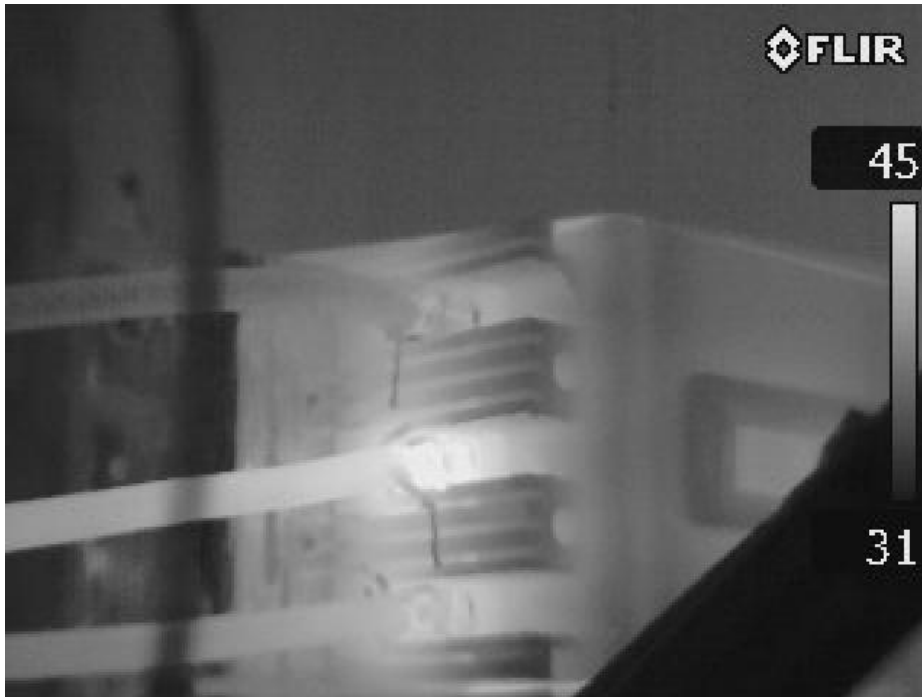
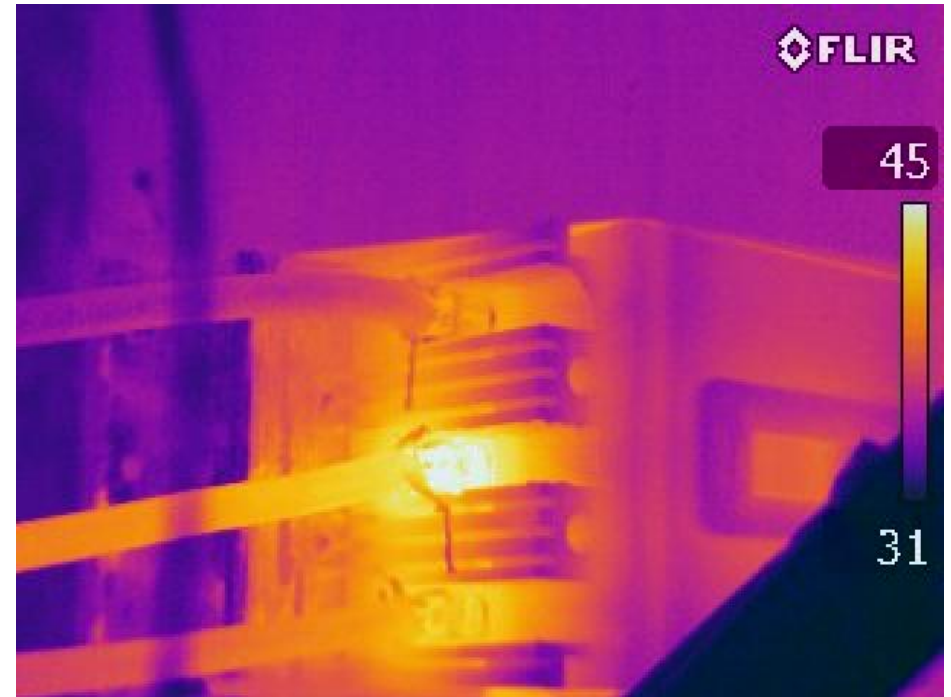
Area/Image No. 4 Job No. 1234.7 Date 12/10/2021 Time 03:15

Location Main Engine Room Equip # Breaker #1

Equipment SWBD Room

Load: Rated 50 Amps Measured 27 Amps % 54%

Ambient Temp 31 °C ΔT 10.00 above Lower Connection

Comments Left Conductor Connection Temperatures:

Upper	41°C
Middle	49°C
Lower	39°C

Obj. Priority 2 Subj. Priority Avg. Priority: 2
