**INFRASONIC™ STEAM SURVEY**

*ABC Company  
123 Main Street  
Anytown, USA*

*Our Job Number: 16-1234.5*

RE: INFRASONIC™ STEAM SYSTEM SURVEY REPORT  
OUR JOB NUMBER: 16-1234.5

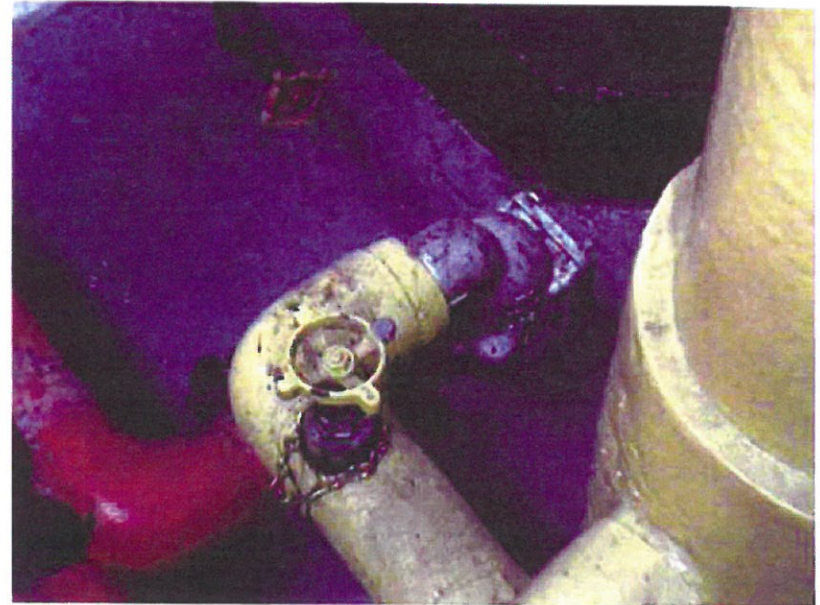
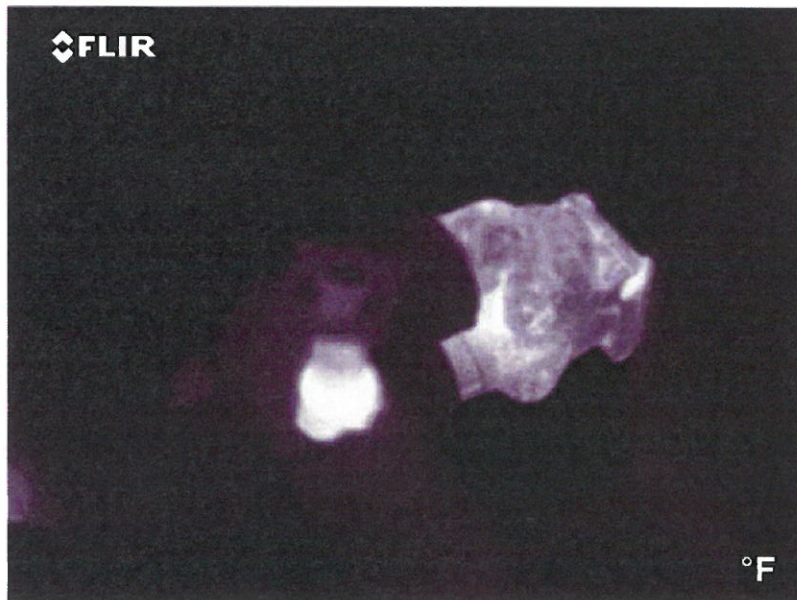
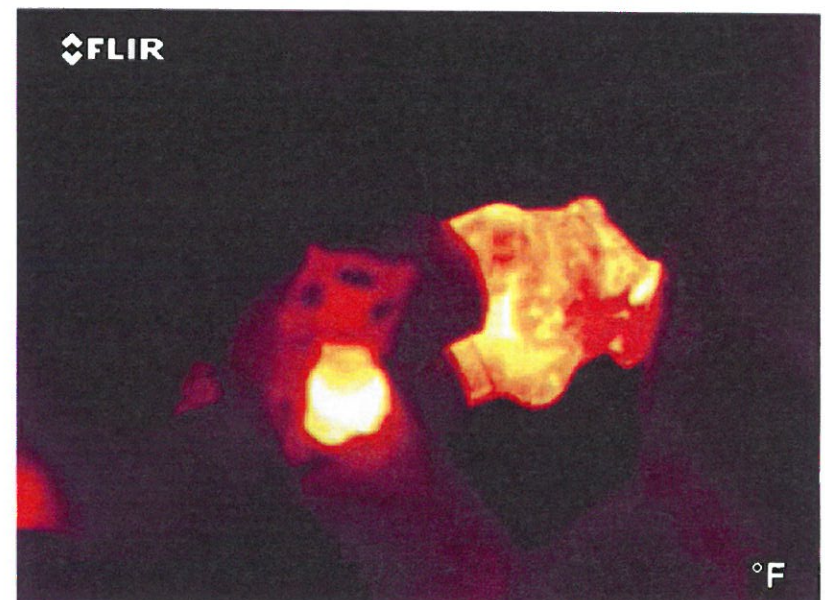
Area/Picture No. 1 Job No. 16-2801.14R Date 2/1/16

Equipment Fan 128, Trap 115

Comments Ultrasonic unit detected trap not closing.

Inlet: 227°F  
Outlet: 226°F

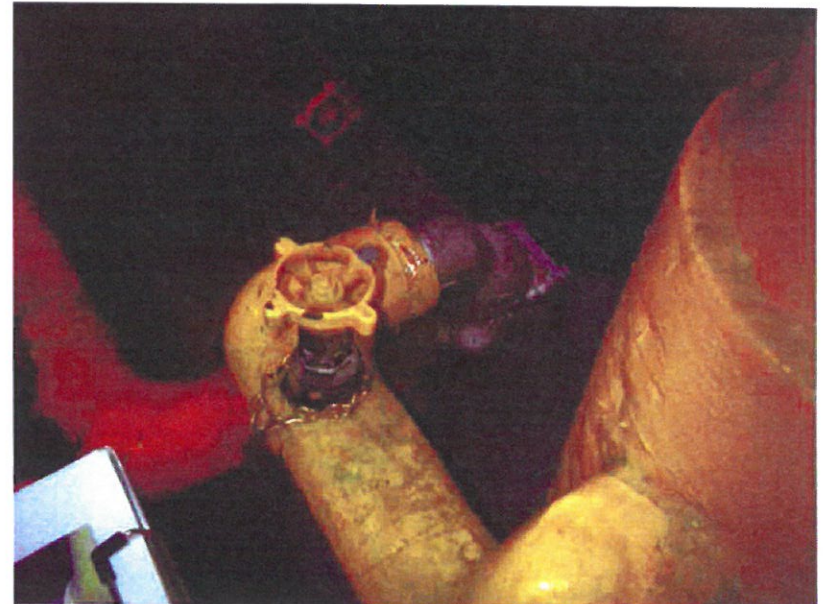
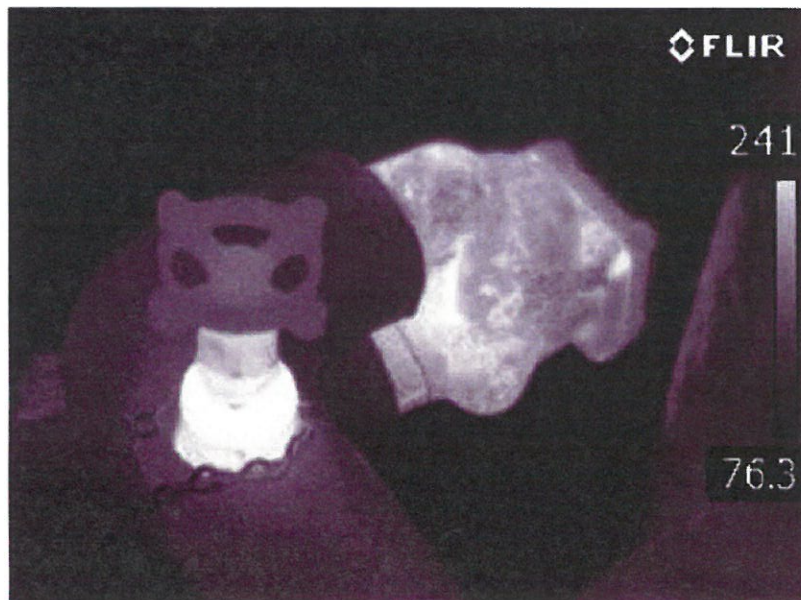
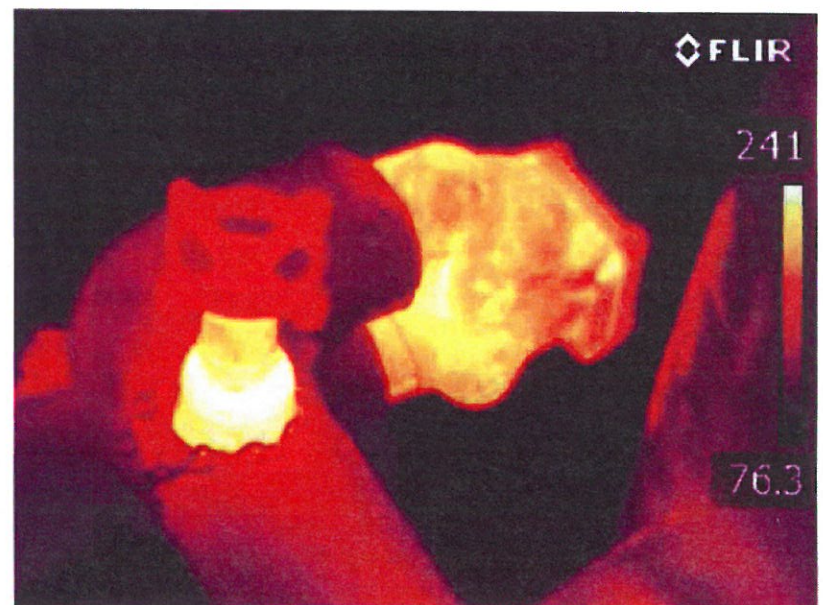
Area/Picture No. 1F Job No. 16-2801.15 Date 4/15/16

Equipment Fan 128, Trap 115

Comments Ultrasonic unit confirmed the trap is opening and closing normally.

Inlet: 216°F  
Outlet: 214°F

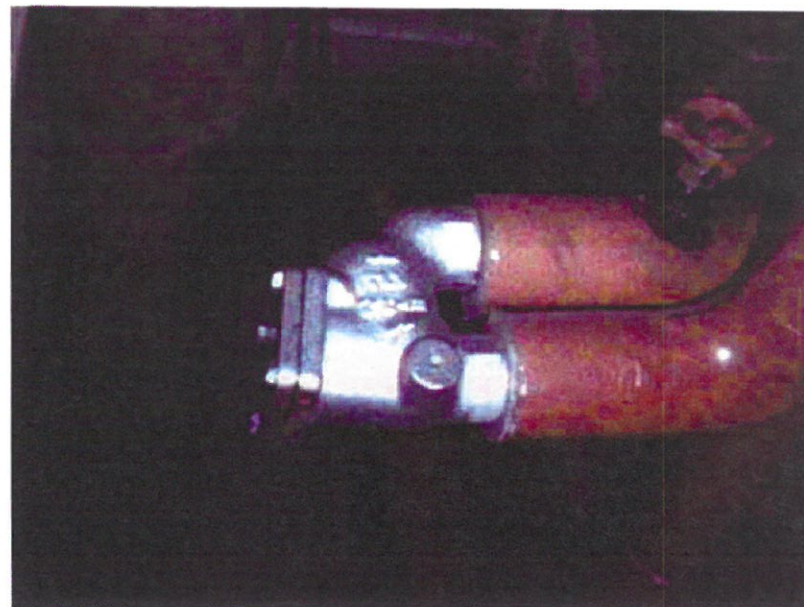
**Area/Picture No.** 3      **Job No.** 16-2801.14R      **Date** 2/3/16  
**Location** 8th Floor, MER  
**Equipment** Fan 132B, Trap 063  
**Wind Speed** N/A      **Wind From** N/A      **Sky** Indoor  
**Emiss.** 1.00    **B/G** N/A°    **Distance** 5'      **Lens** 1x  
**Rated Load** N/A      **Measured Load** N/A      **% Load**  
**Ambient Temp** N/A      **N/A ° Rise Over** N/A  
**Comments** Leaking Trap

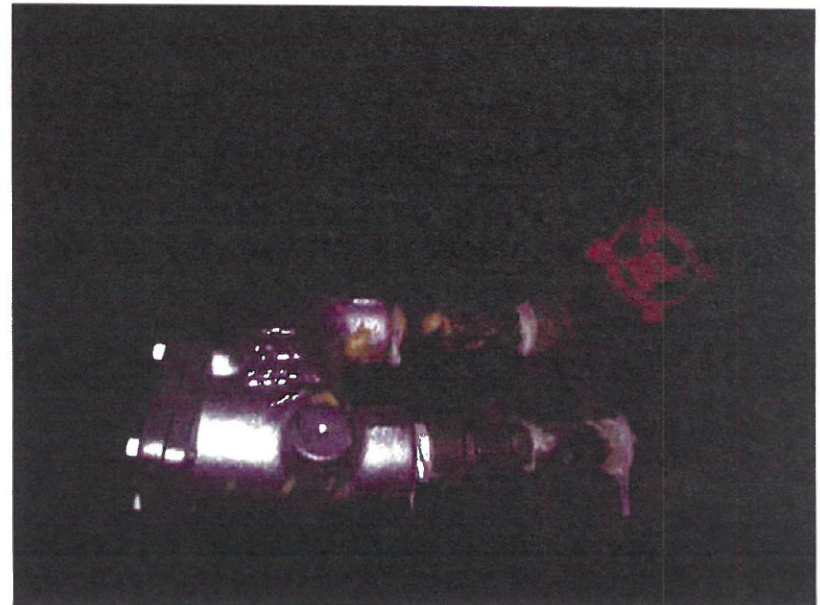
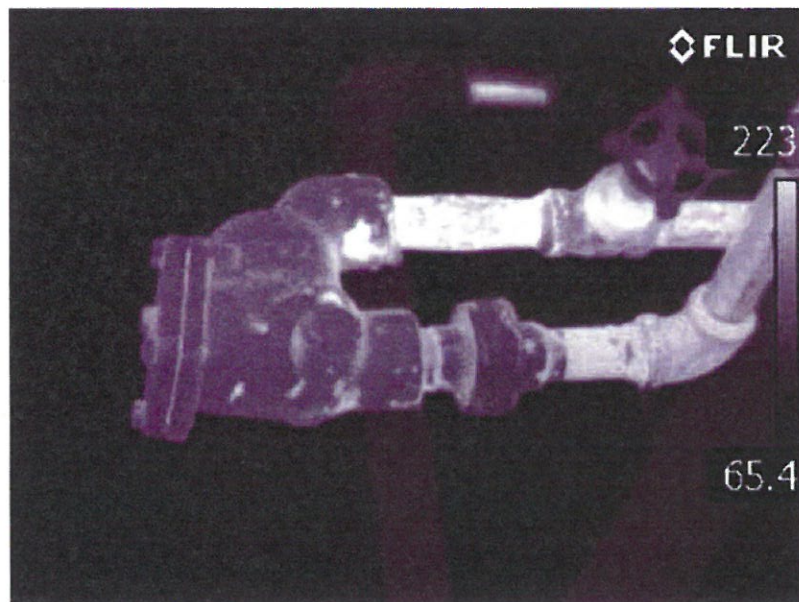
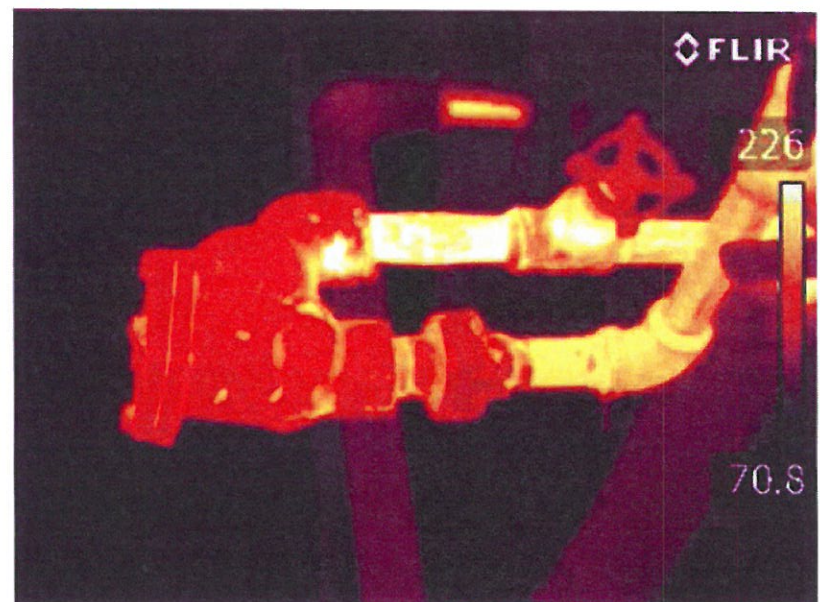
Area/Picture No. 3F Job No. 16-2801.15 Date 4/15/16

Equipment Fan 132B, Trap 063

Comments Ultrasonic unit confirmed the trap is opening and closing properly and the leak is repaired.

Inlet: 225°F  
Outlet: 219°F

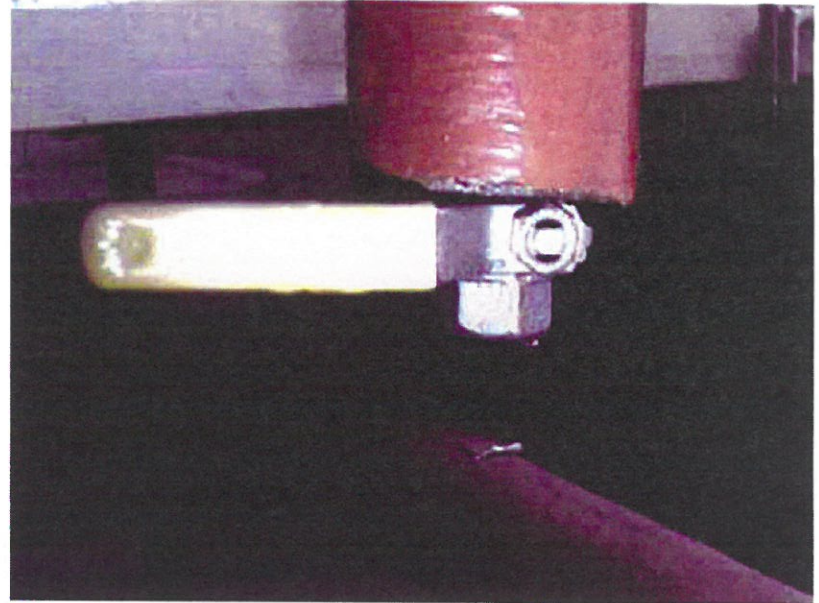
**Area/Picture No.** 4      **Job No.** 16-2801.14R      **Date** 2/3/16  
**Location** 8th Floor, MER  
**Equipment** Valve at 045 Trap  
**Wind Speed** N/A      **Wind From** N/A      **Sky** Indoor  
**Emiss.** 1.00    **B/G** N/A°    **Distance** 5'      **Lens** 1x  
**Rated Load** N/A      **Measured Load** N/A      **% Load**  
**Ambient Temp** N/A      **N/A ° Rise Over** N/A  
**Comments** Valve leaking while closed.

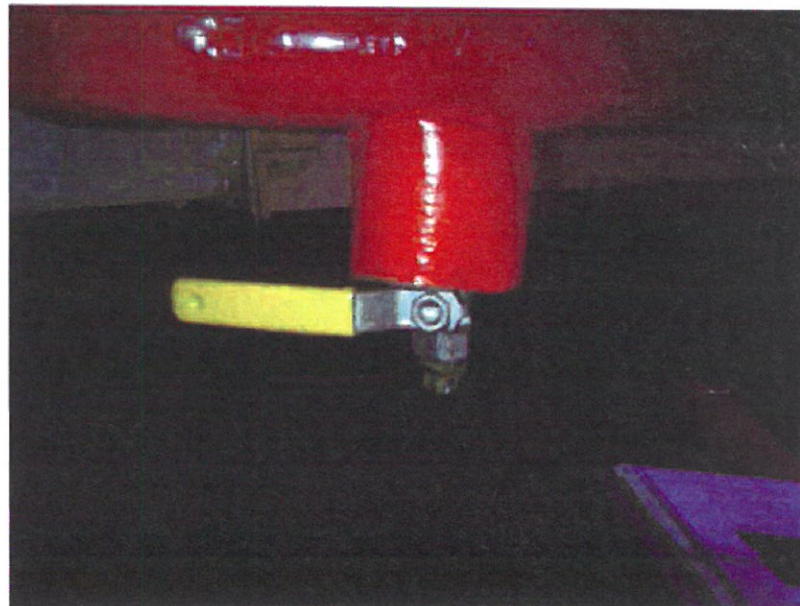
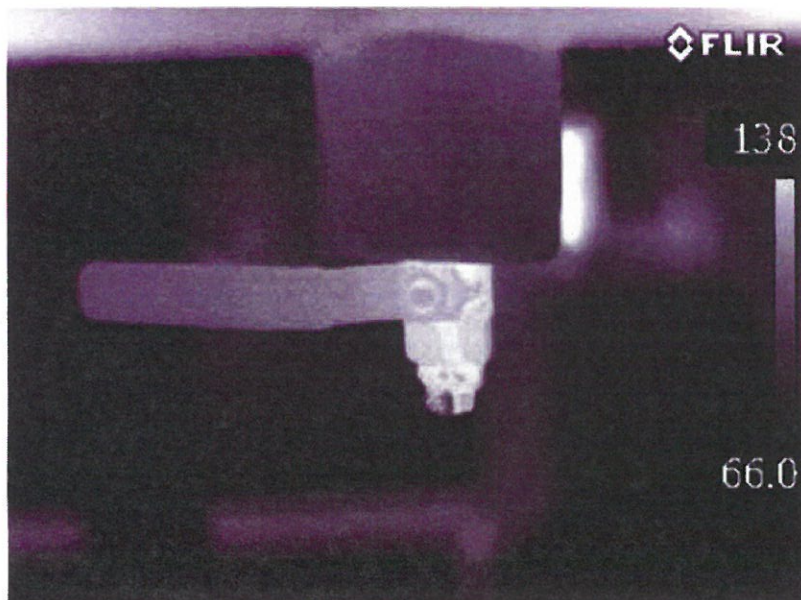
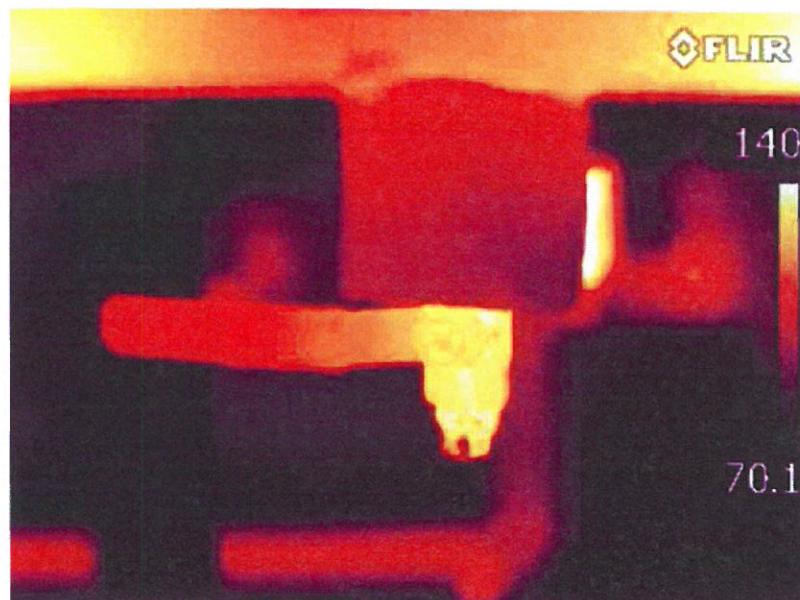
Area/Picture No. 4F Job No. 16-2801.15 Date 4/15/16

Equipment Valve at 045 Trap

Comments A plug has been installed and no leak was occurring at the time of the Survey.

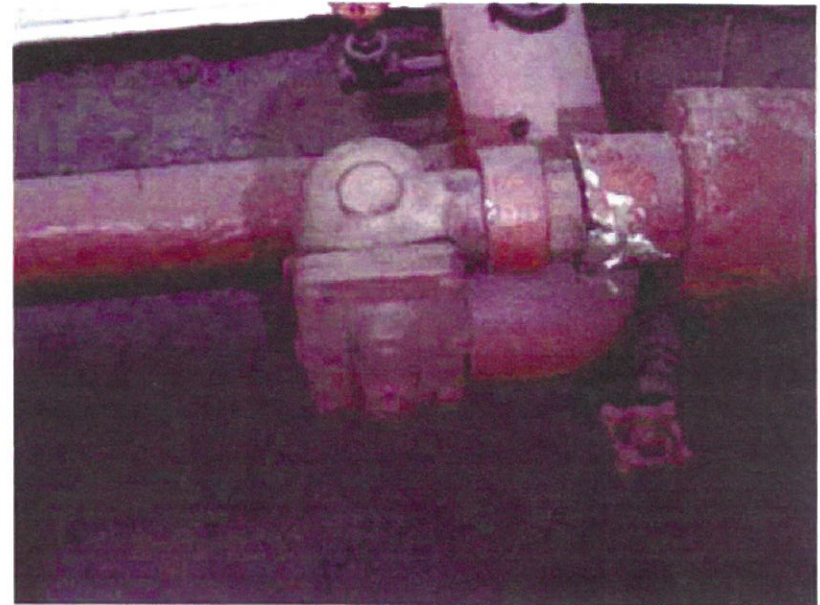
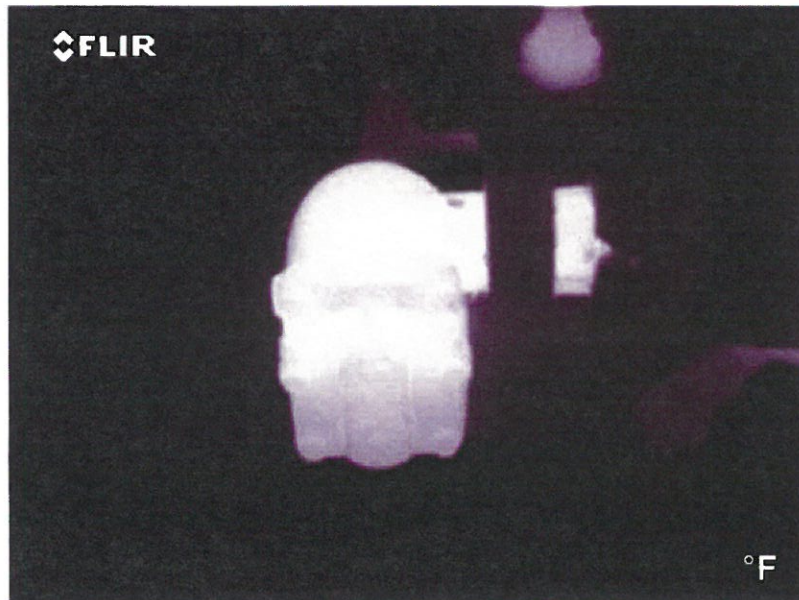
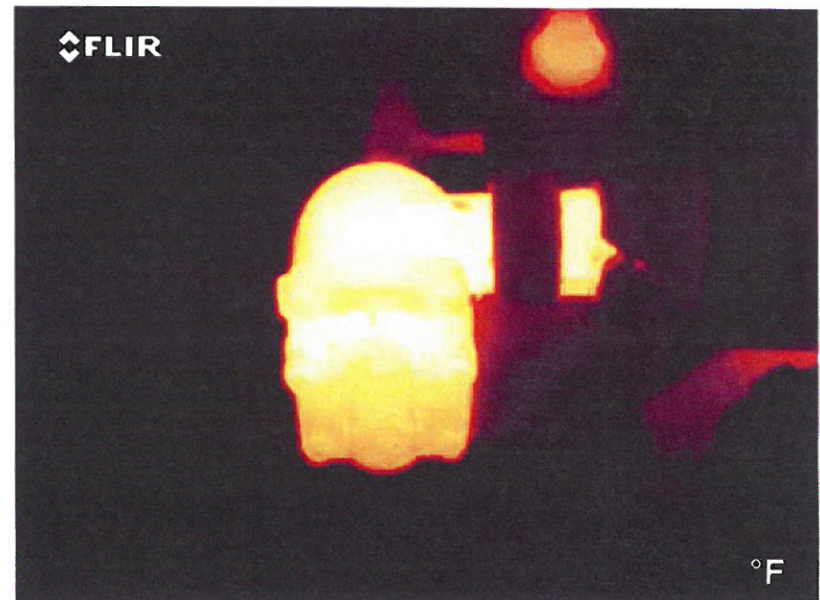
Area/Picture No. 5 Job No. 16-2801.14R Date 2/3/16

Equipment LP Main Drip 2, Trap 077

Comments Ultrasonic unit detected trap not closing:

Inlet: 228°F  
Outlet: 215°F

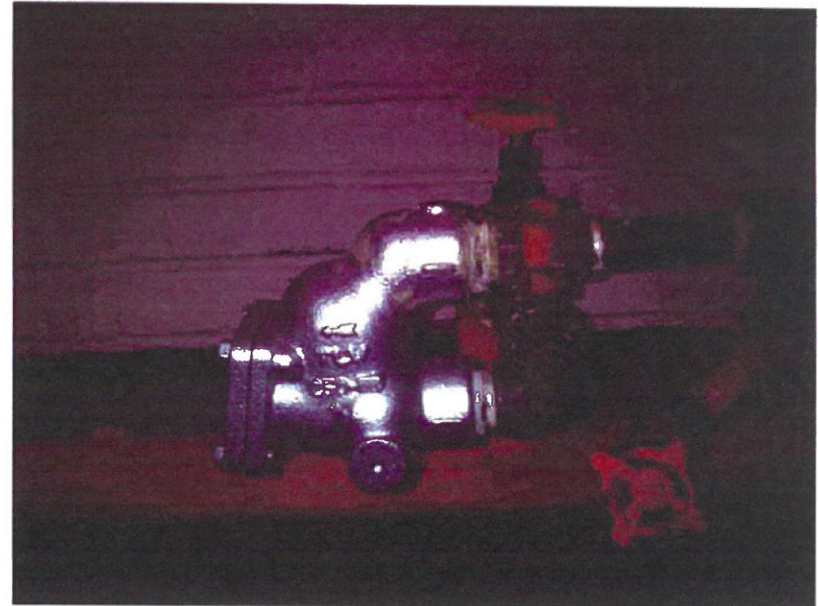
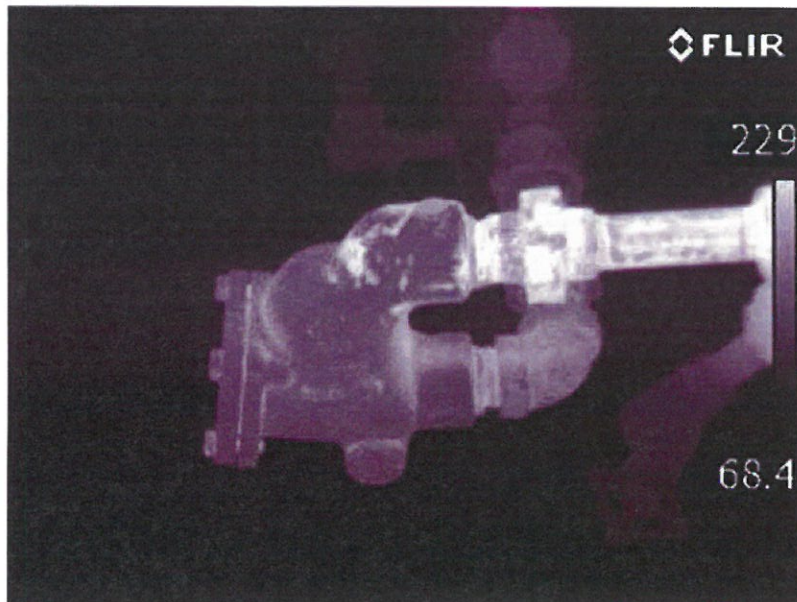
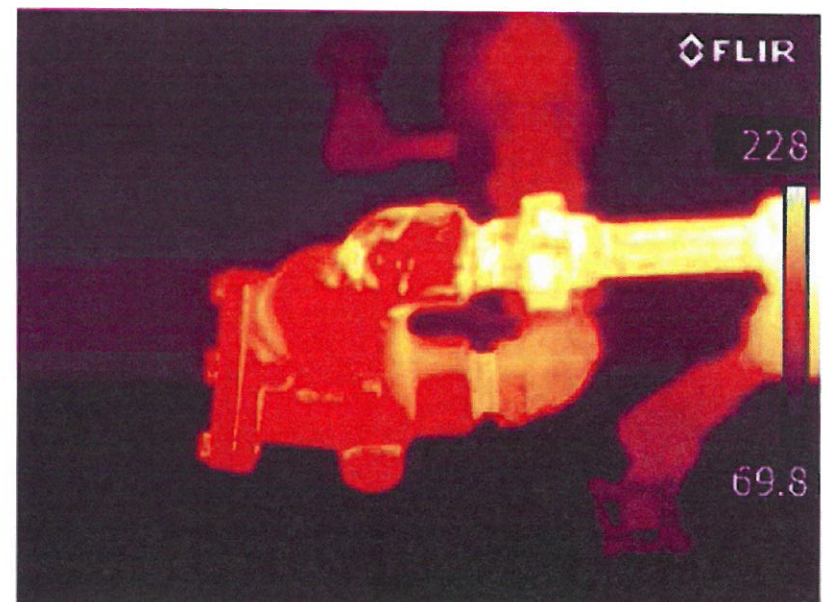
Area/Picture No. 5F Job No. 16-2801.15 Date 4/15/16

Equipment LP Main Drip 2, Trap 077

Comments Trap has been replaced. Ultrasonic unit confirmed the trap is opening and closing normally.

Inlet: 228°F  
Outlet: 215°F

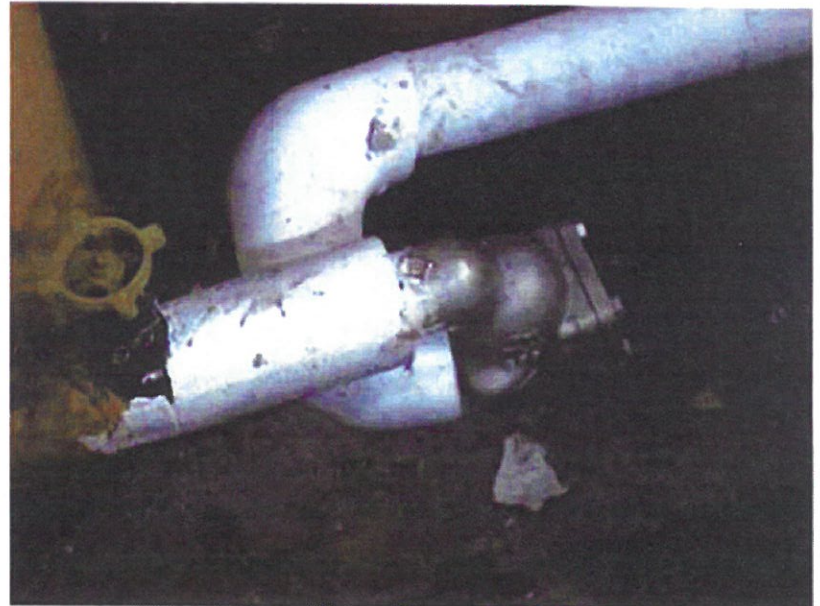
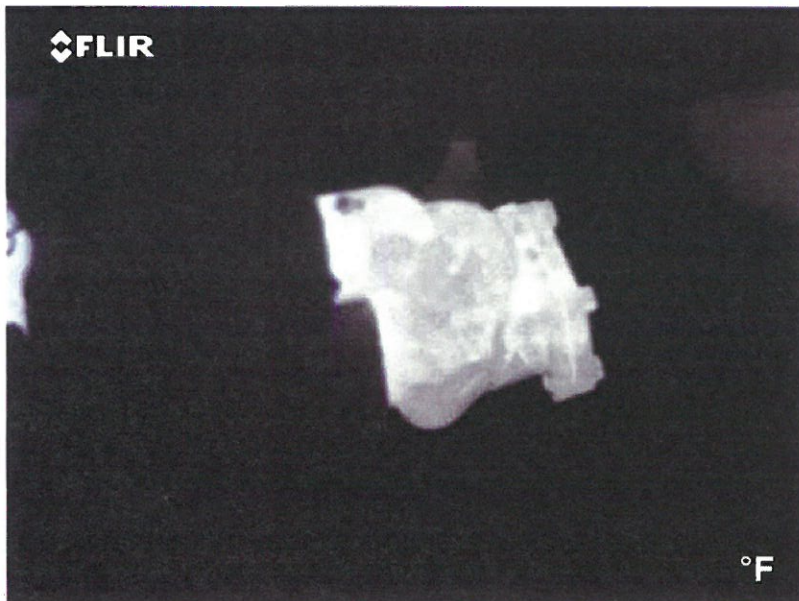
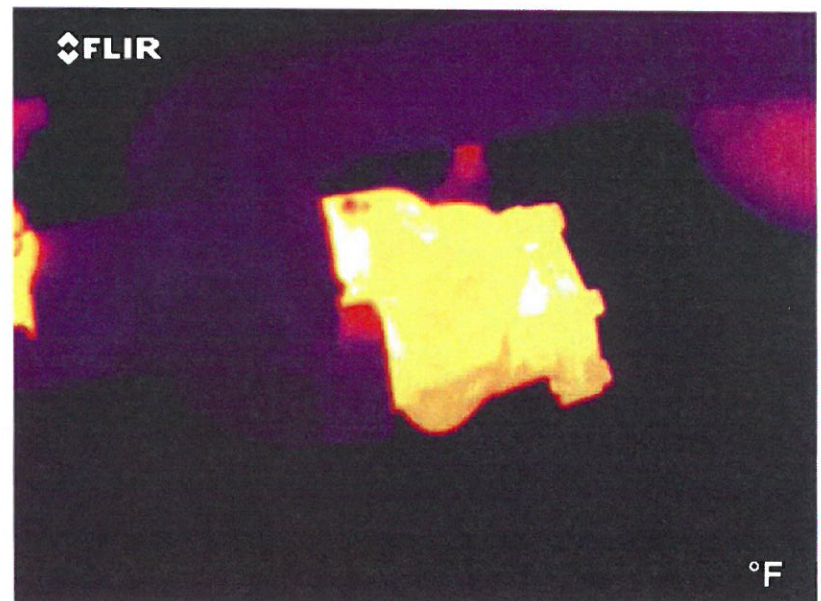
Area/Picture No. 7 Job No. 16-2801.14 Date 2/2/16

Equipment Fan 119, Trap 138

Comments Ultrasonic unit detected trap not closing.

Inlet: 235°F  
Outlet: 228°F

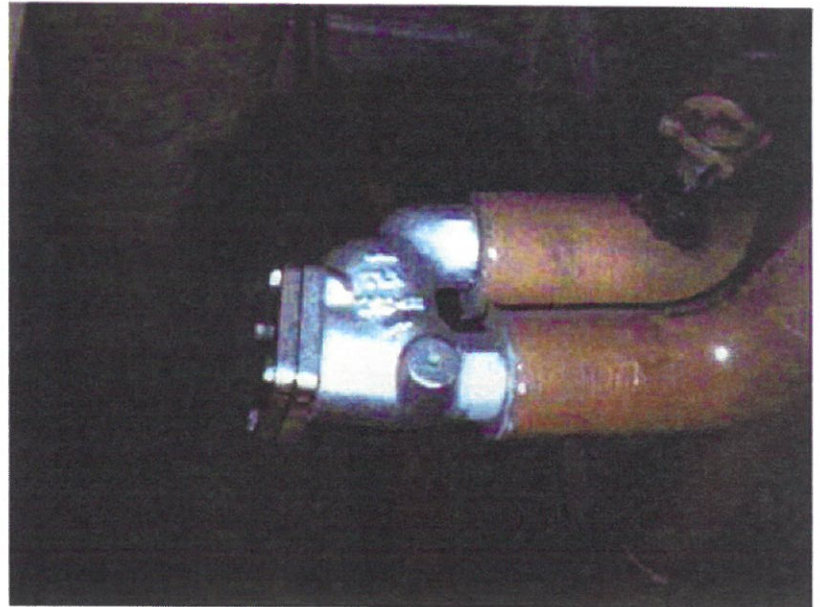
**Area/Picture No.** 9      **Job No.** 16-2801.14      **Date** 2/3/16  
**Location** 8th Floor, MER  
**Equipment** Fan 132B, Trap 063  
**Wind Speed** N/A      **Wind From** N/A      **Sky** Indoor  
**Emiss.** 1.00    **B/G** N/A°    **Distance** 5'      **Lens** 1x  
**Rated Load** N/A      **Measured Load** N/A      **% Load**  
**Ambient Temp** N/A      **N/A ° Rise Over** N/A  
**Comments** Leaking Trap

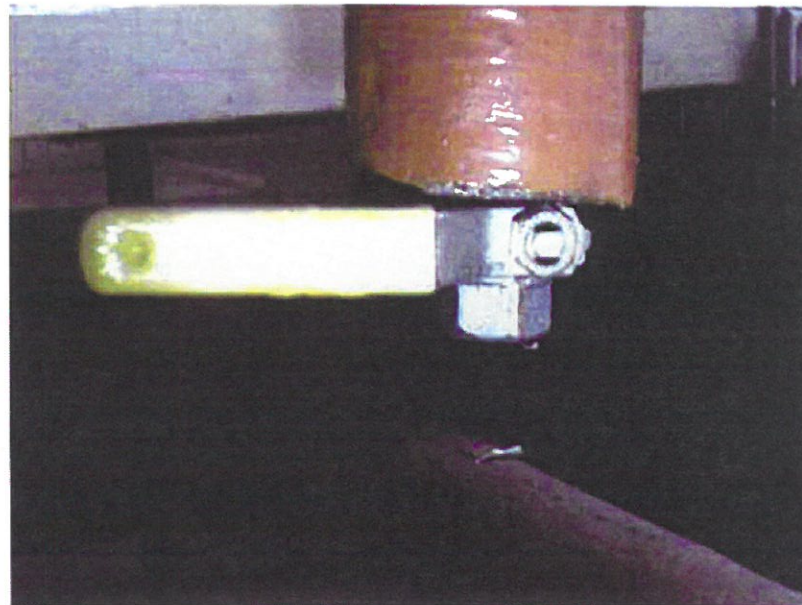
**Area/Picture No.** 10    **Job No.** 16-2801.14    **Date** 2/3/16  
**Location** 8th Floor, MER  
**Equipment** Valve at 045 Trap  
**Wind Speed** N/A    **Wind From** N/A    **Sky** Indoor  
**Emiss.** 1.00    **B/G** N/A°    **Distance** 5'    **Lens** 1x  
**Rated Load** N/A    **Measured Load** N/A    **% Load**  
**Ambient Temp** N/A    **N/A ° Rise Over** N/A  
**Comments** Valve leaking while closed.

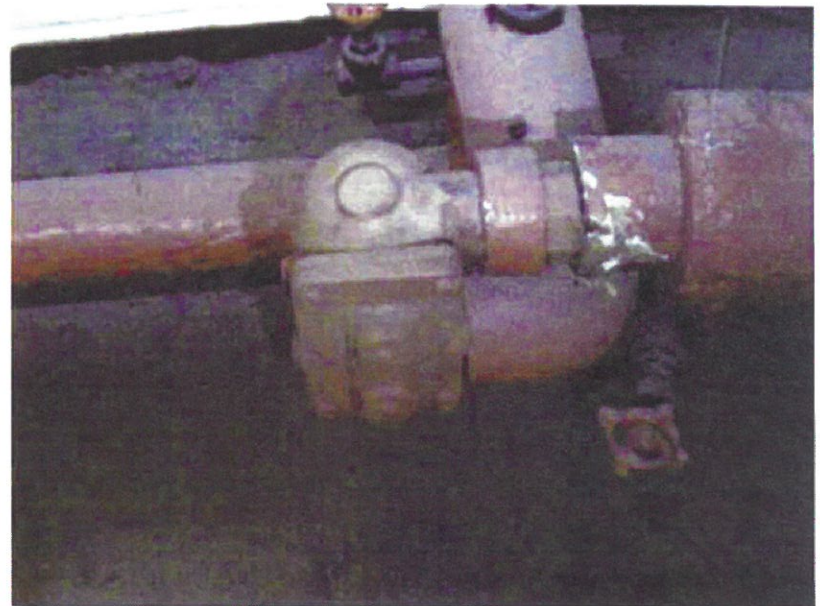
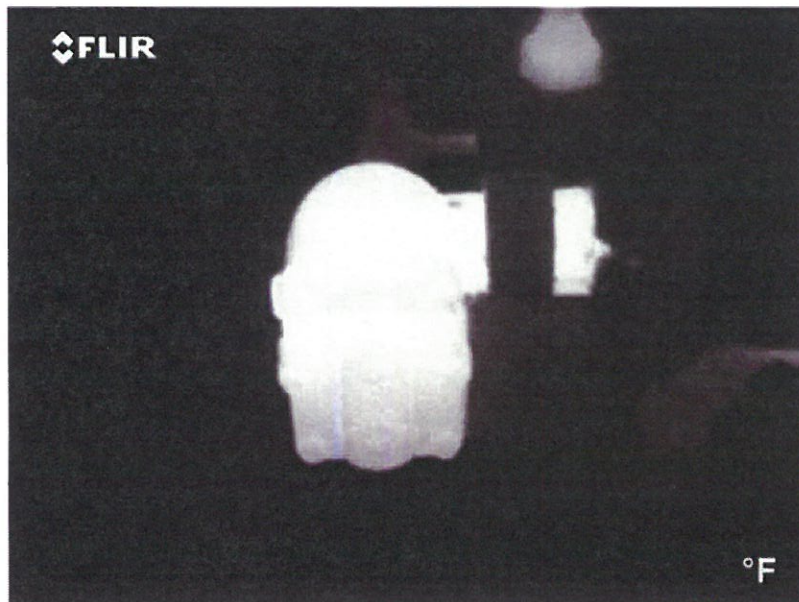
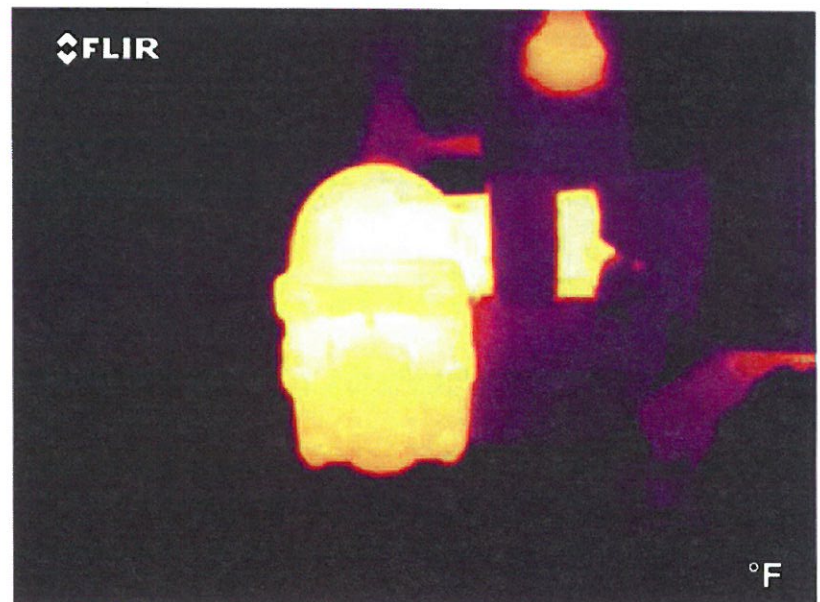
Area/Picture No. 11 Job No. 16-2801.14 Date 2/3/16

Equipment LP Main Drip 2, Trap 077

Comments Ultrasonic unit detected trap not closing.

Intake: 228°F  
Output: 215°F
