Infrared Inspection Report

ACME Manufacturing Company
100 Main Street
My Town, Any State 00000

Shamrock Sheet Metal Corporation
6789 Old Bridge Road
Montclair, NJ 07042

RE: INFRARED BUILDING ENVELOPE SURVEY REPORT
OUR JOB NUMBER: 21-1234.23

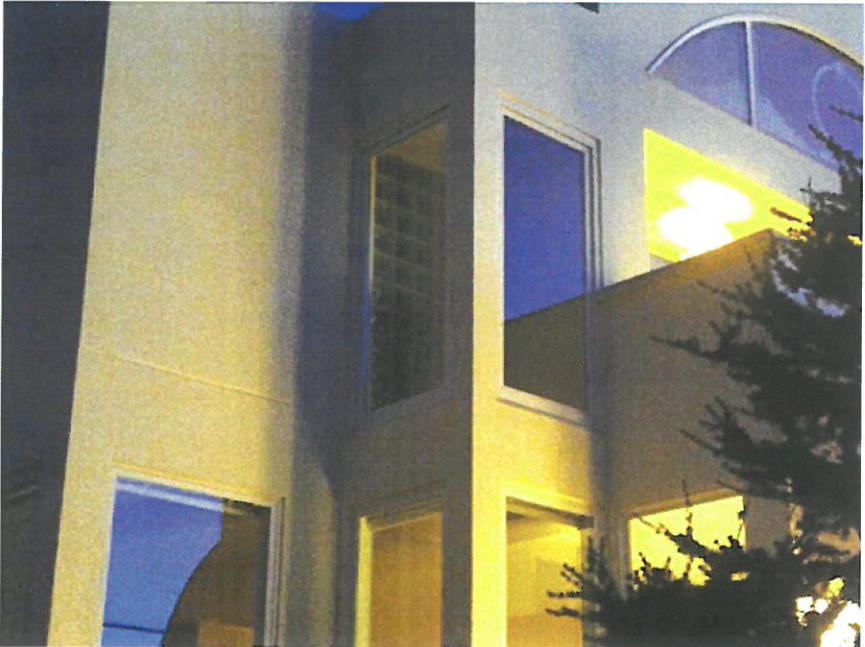
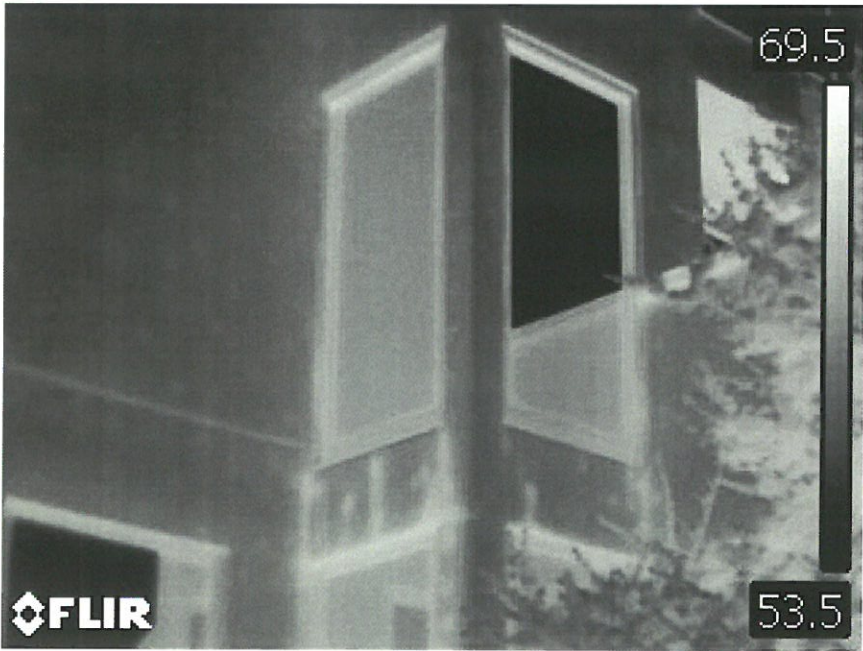
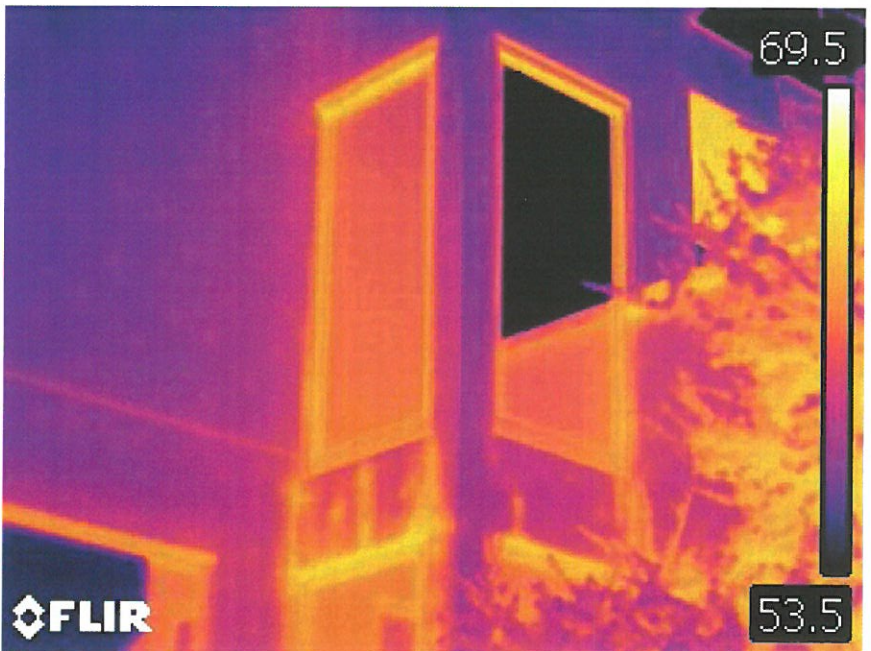
Area/Image No. 1 **Job No.** 21-1234.23
Date 04/12/2021 **Time** 18:54
Location Bottom of NE 2nd Floor, Window Front Side
Equipment Exterior Wall

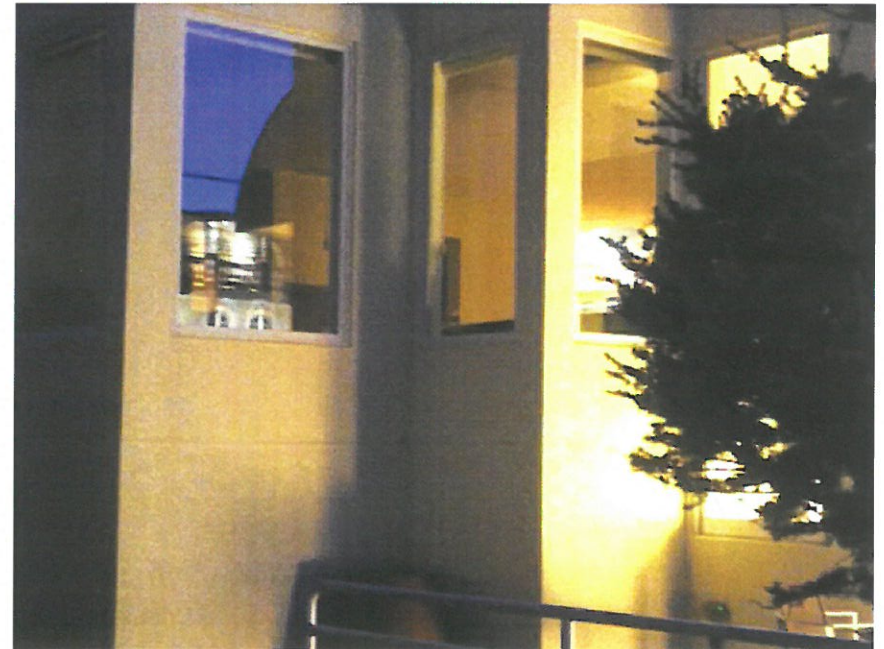
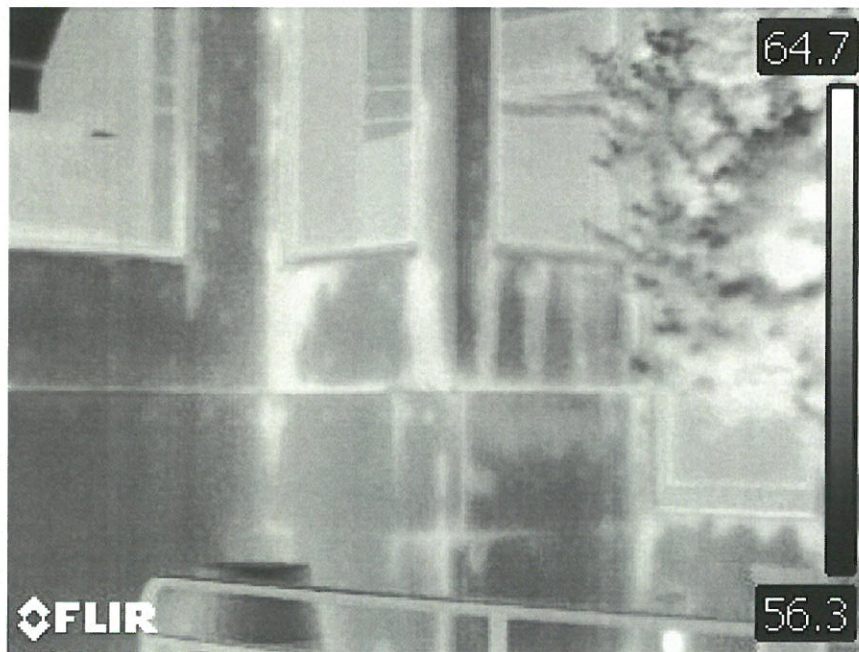
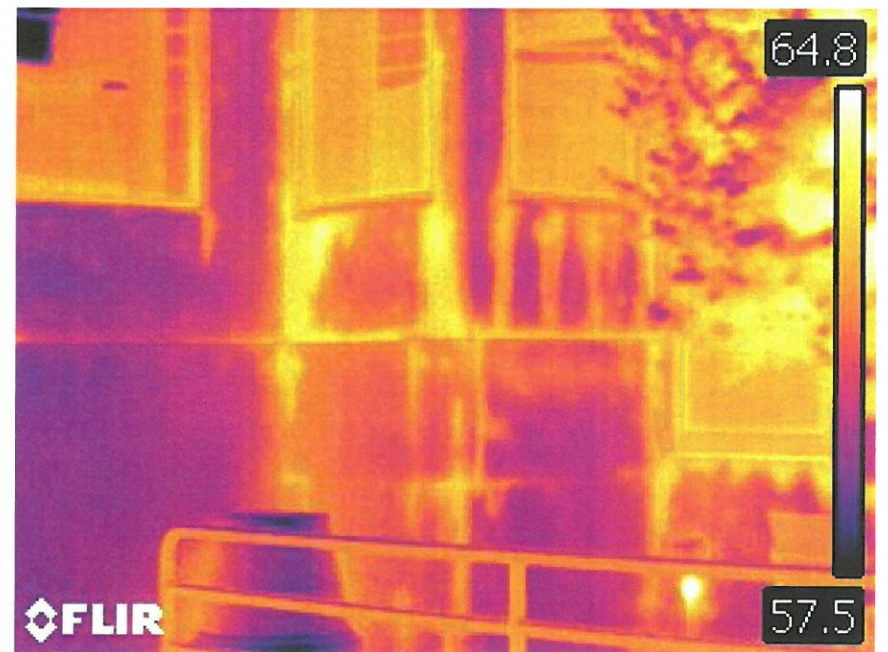
Location 1st Floor, NE below Window

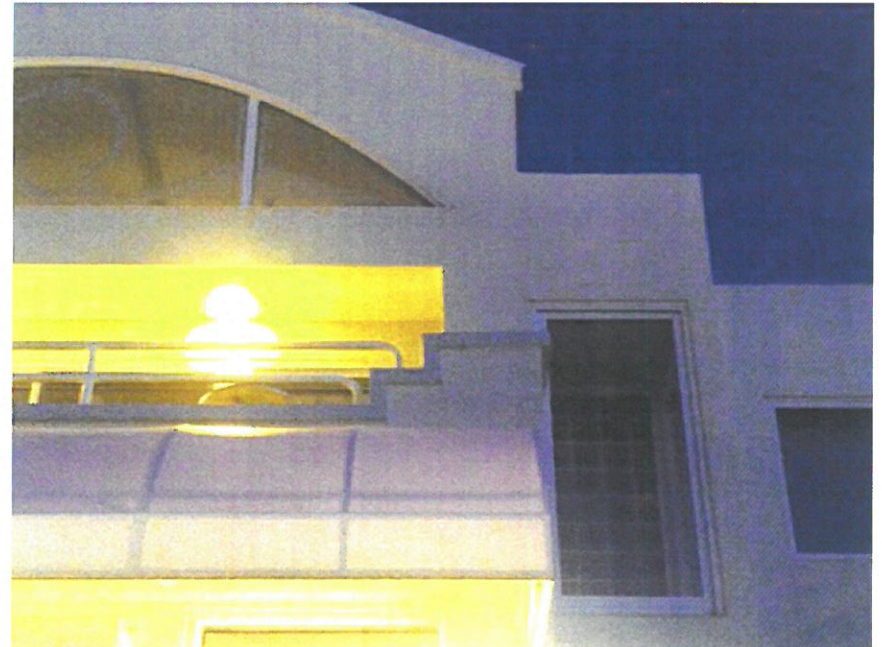
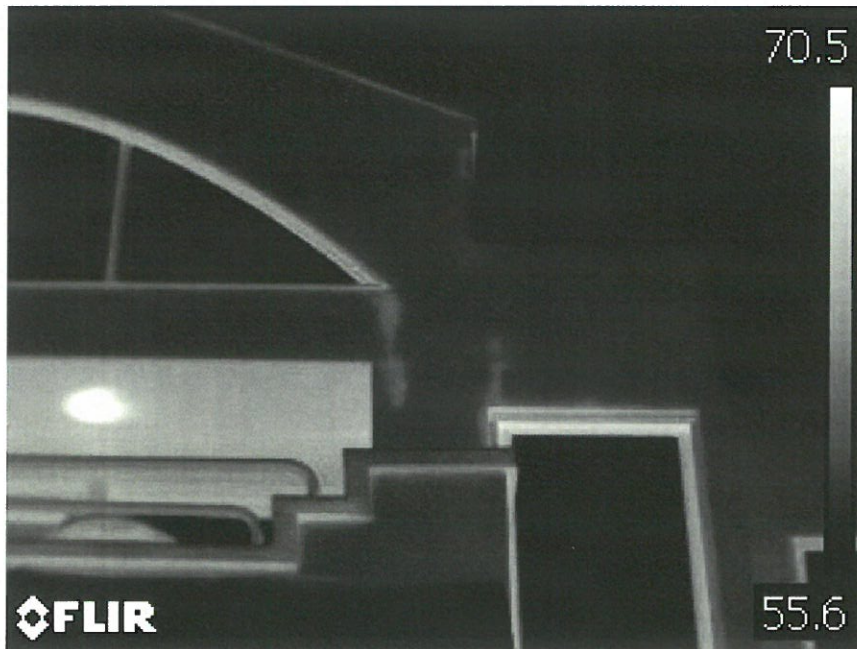
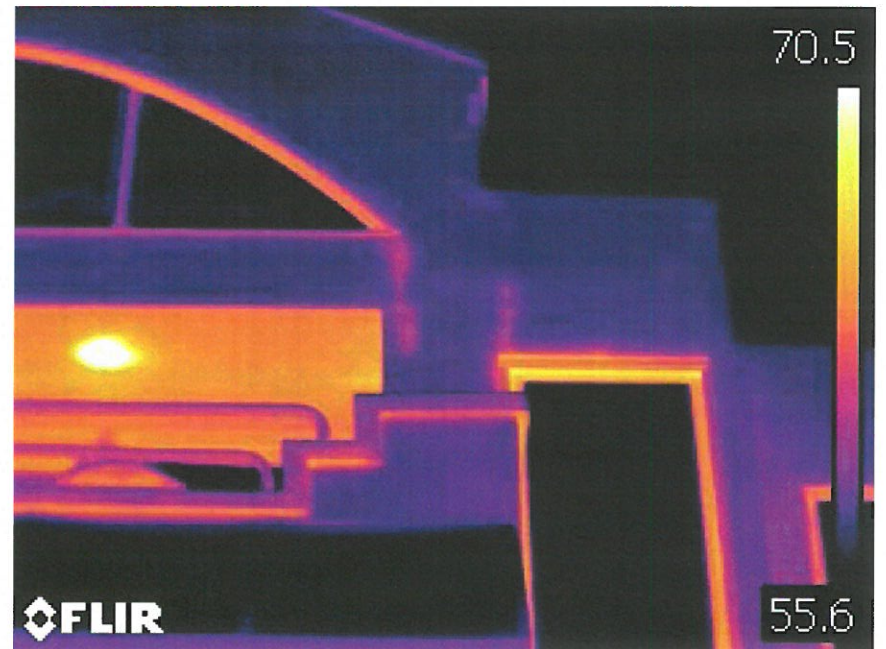
Area/Image No. 3 **Job No.** 21-1234.23
Date 04/12/2021 **Time** 18:57
Location Window above Balcony, SE Corner
Equipment Exterior Wall

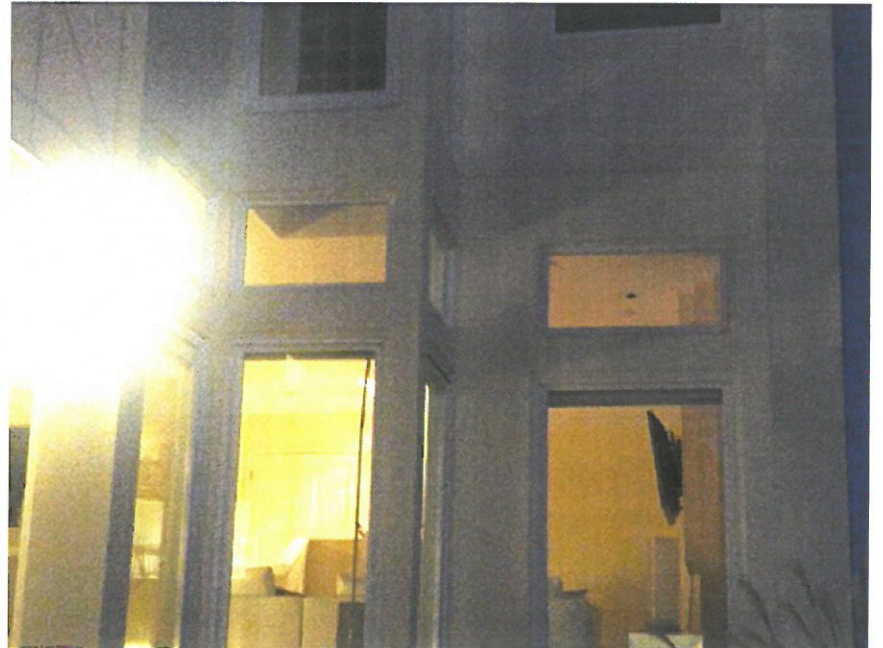
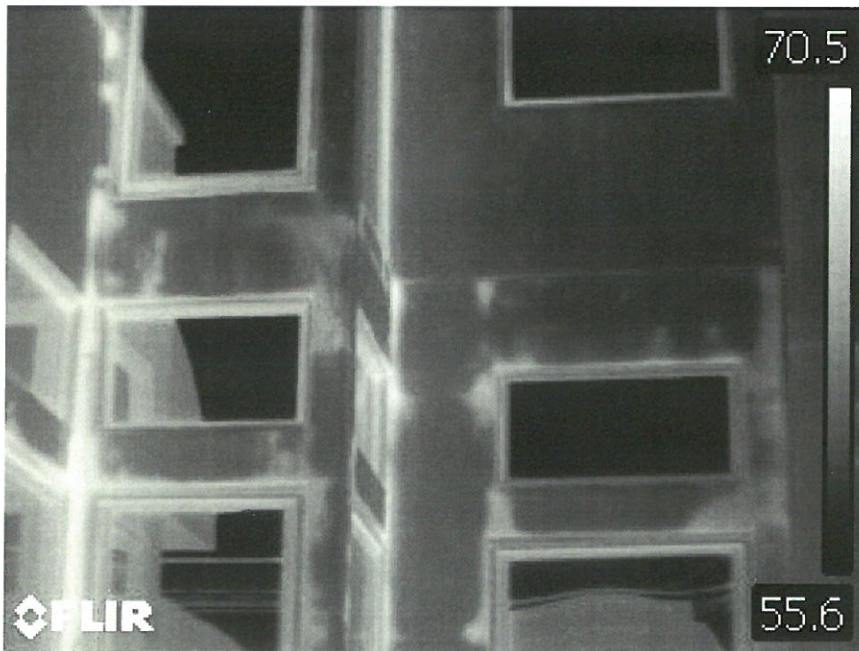
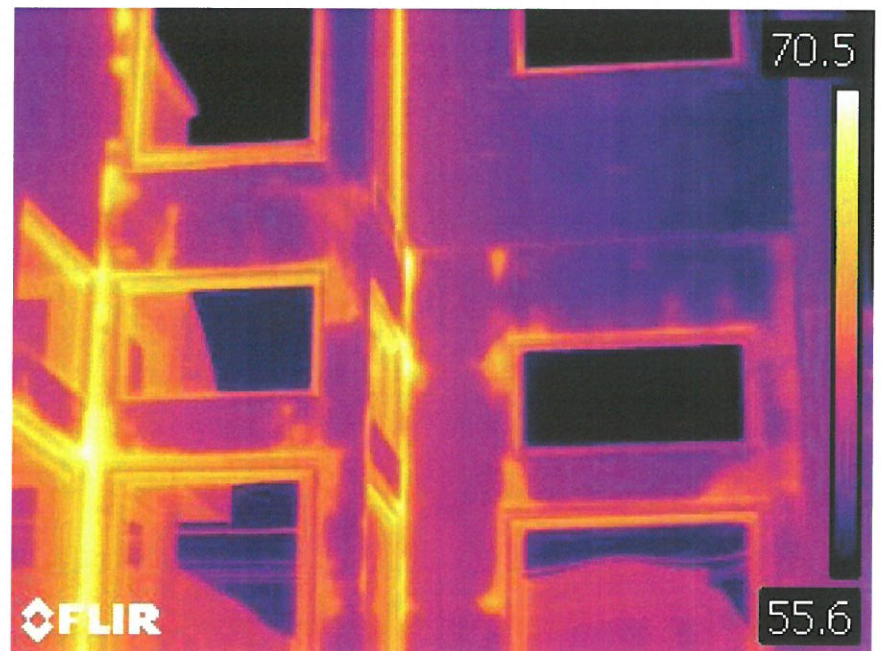
Location 1st Floor, Upper Level Windows

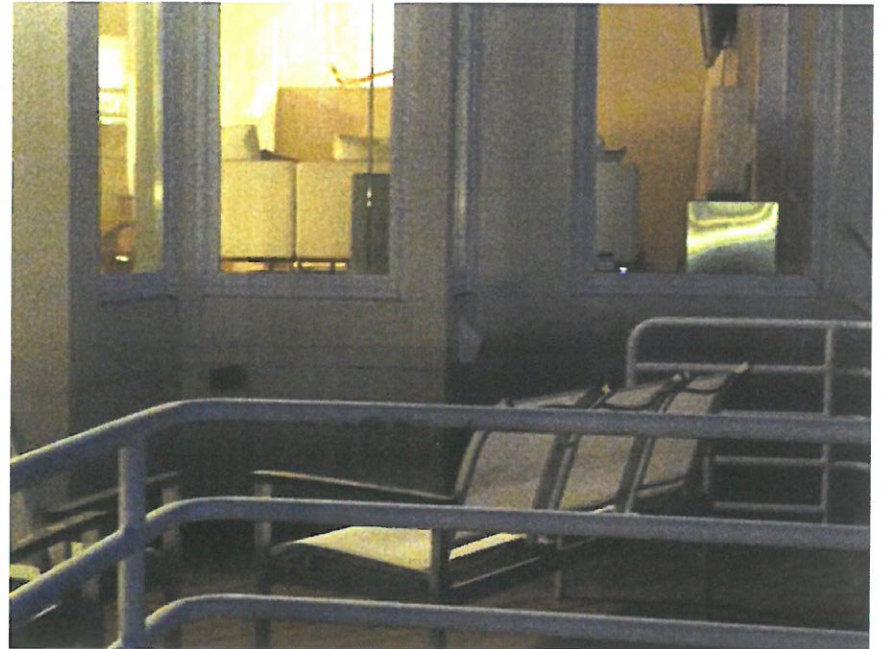
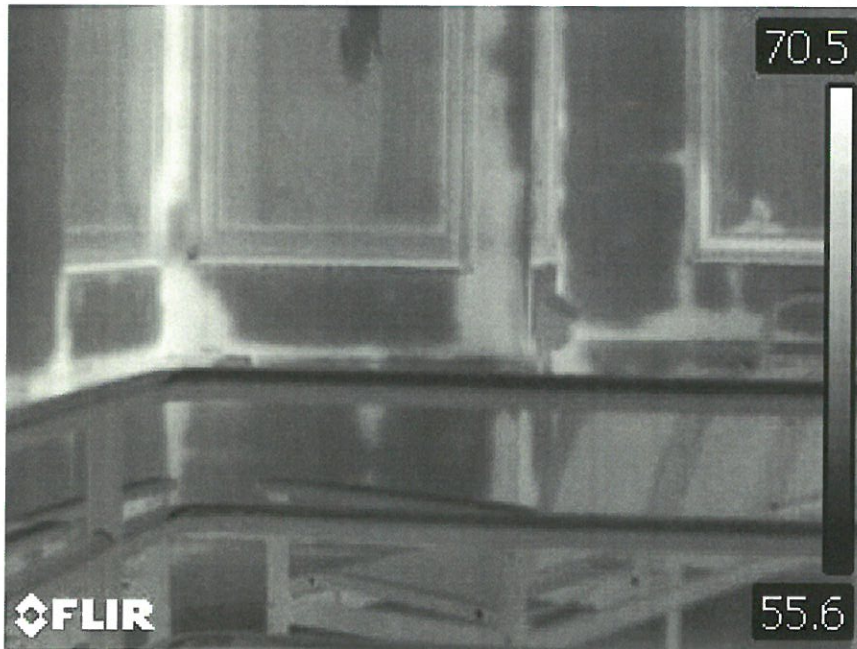
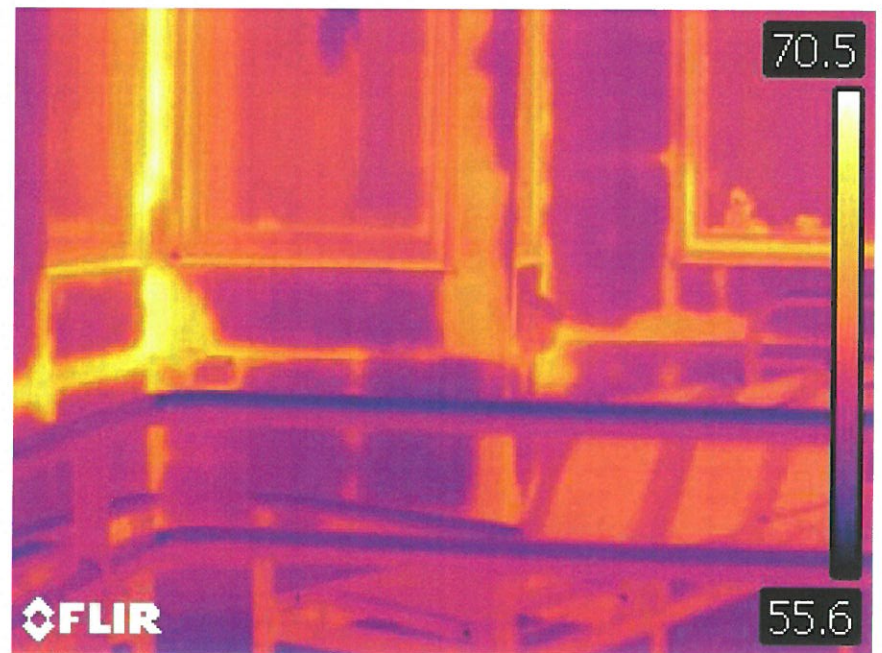
Area/Image No. 5 **Job No.** 21-1234.23
Date 04/12/2021 **Time** 19:04
Location Below and Around 1st Floor Windows, SE Corner
Equipment Exterior Wall

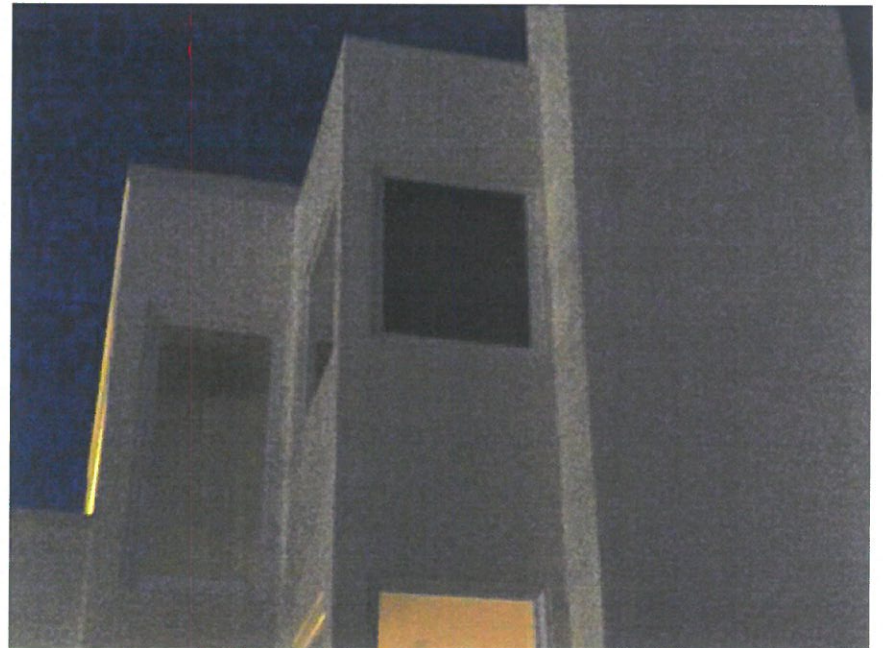
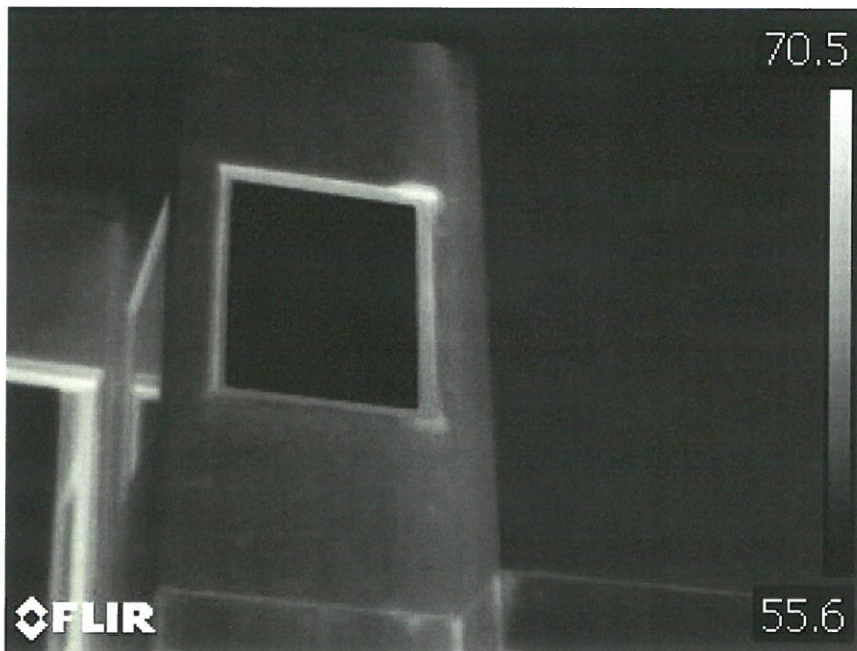
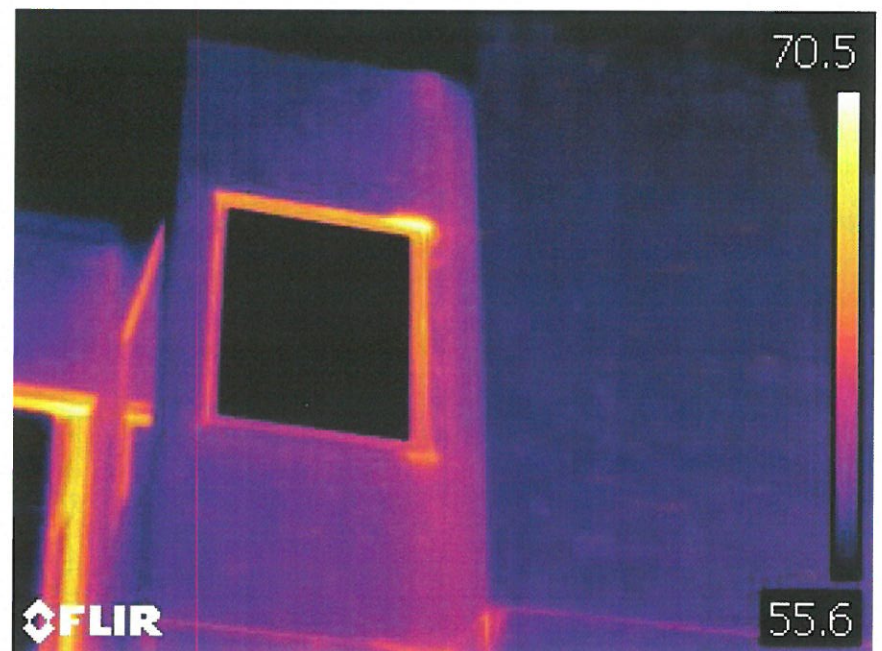
Location South Side, around 2nd Floor Window

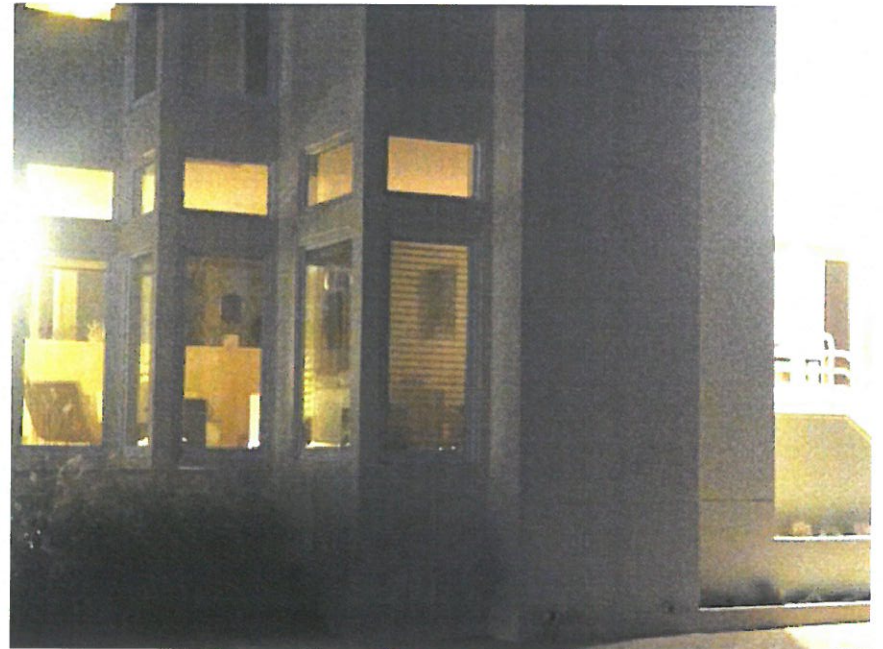
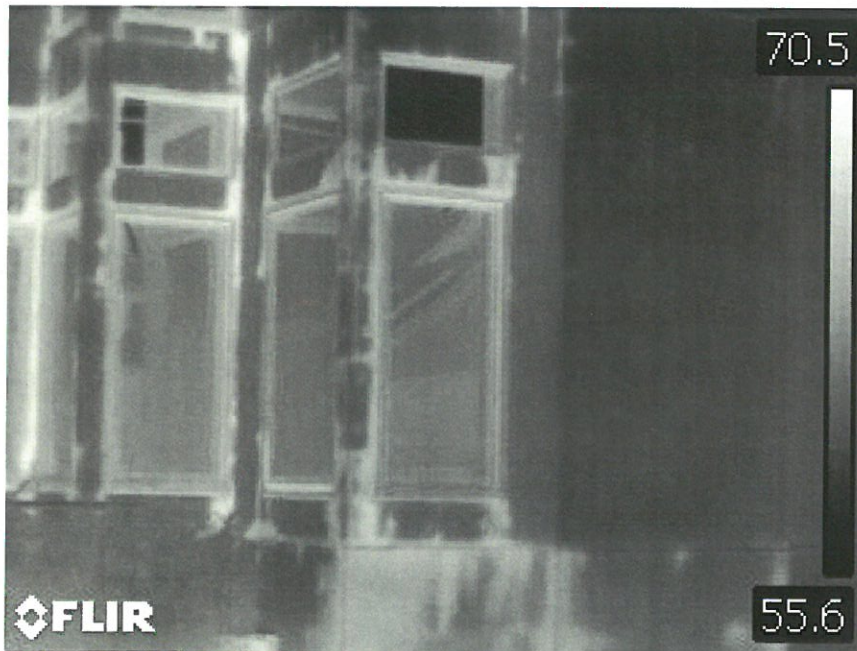
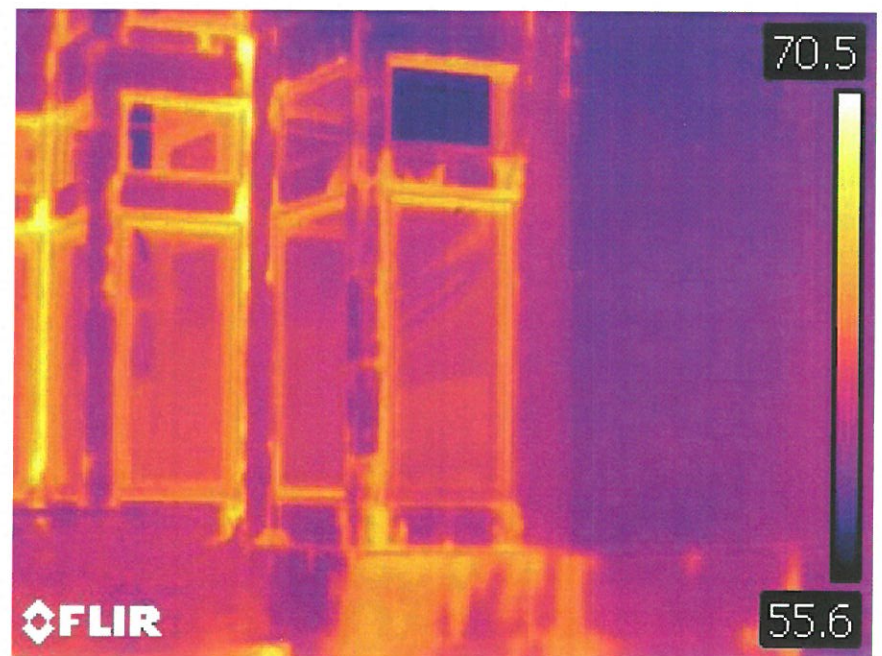
Area/Image No. 7 **Job No.** 21-1234.23
Date 04/12/2021 **Time** 19:06
Location South Side, SE Corner around 1st Floor Windows
Equipment Exterior Wall

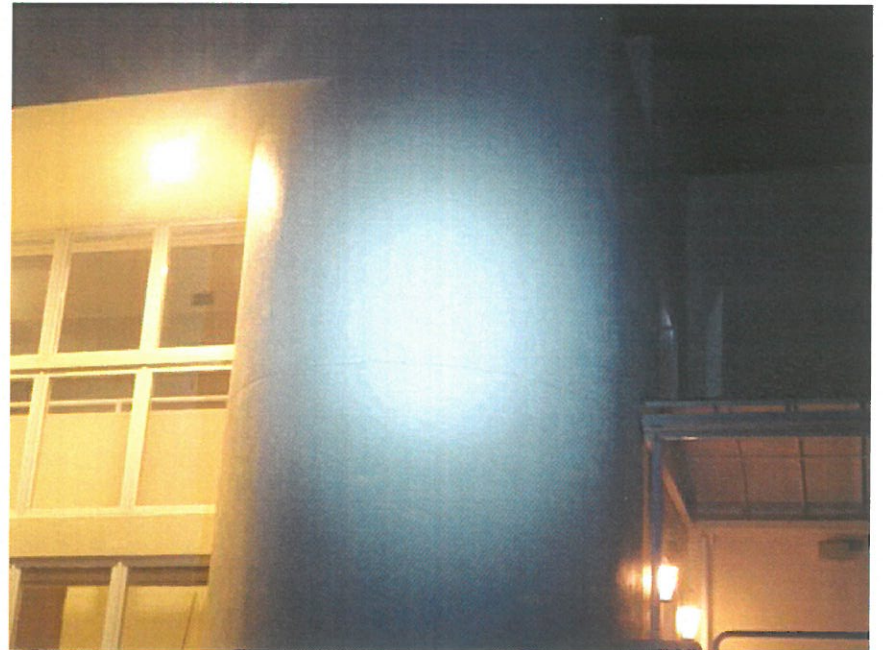
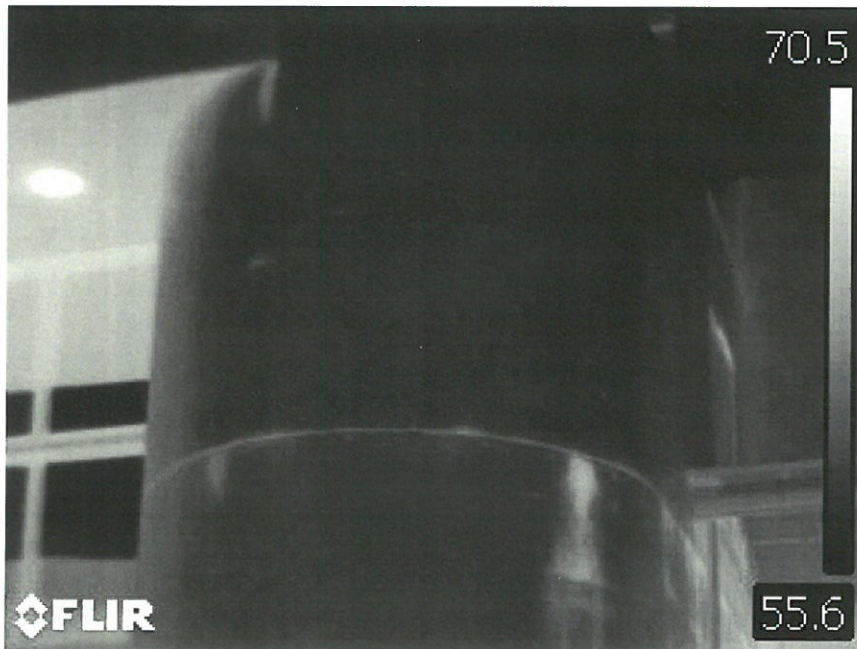
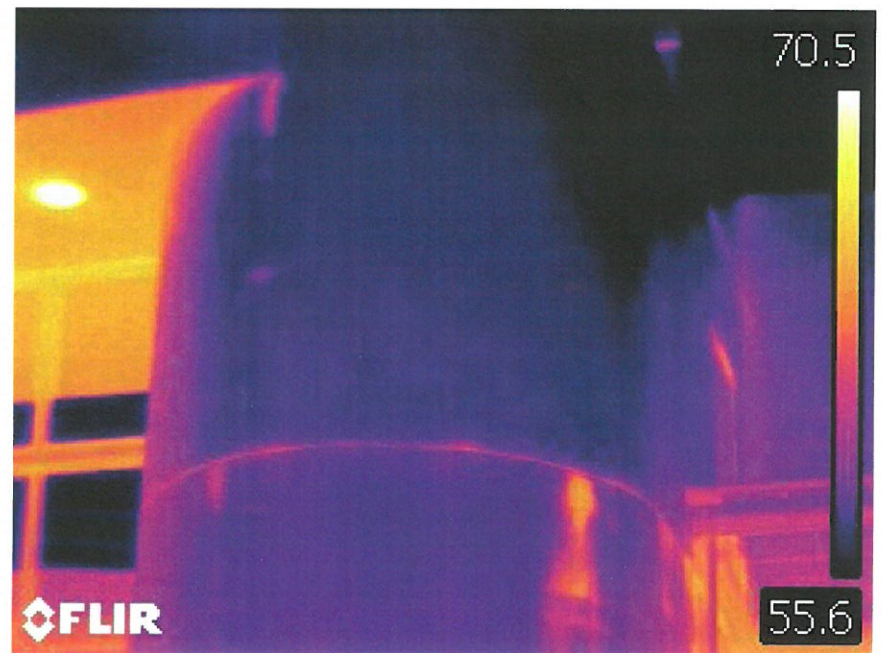
Location South Side, SW Section of Column

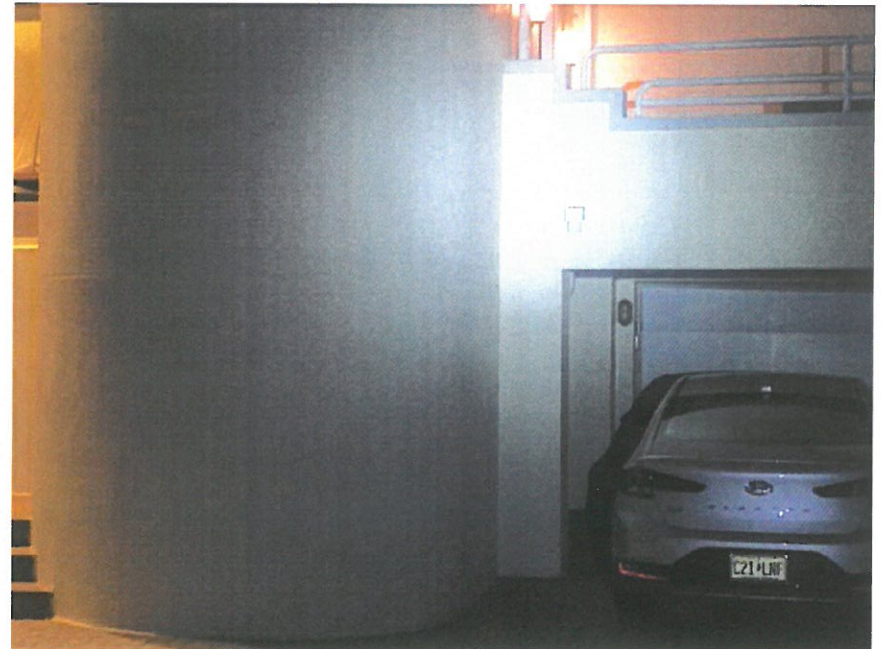
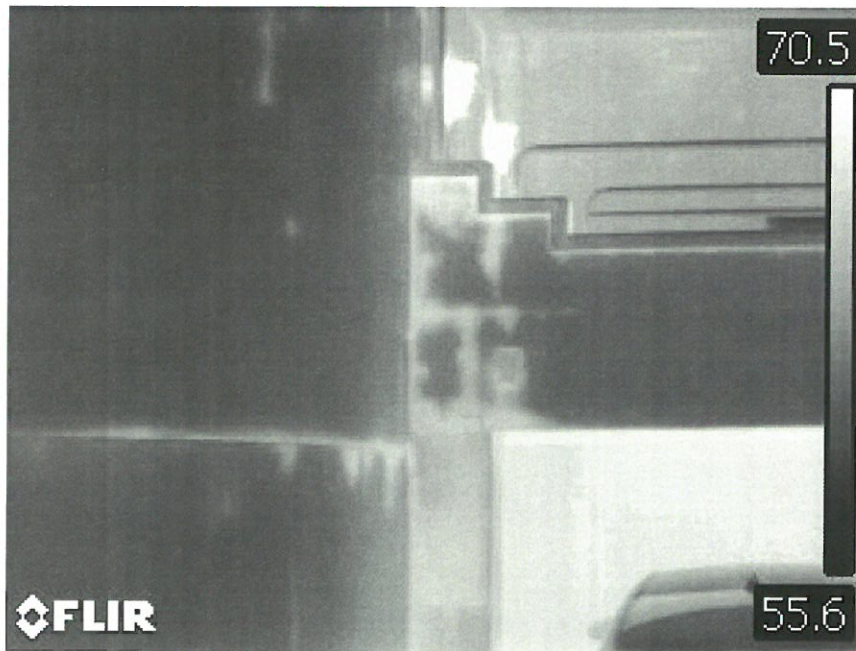
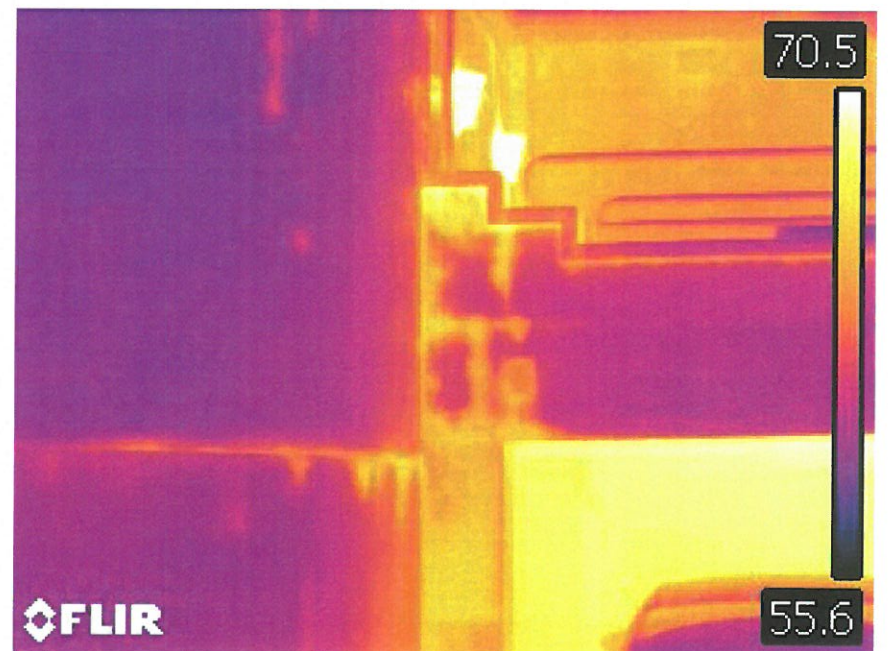
Area/Image No. 9 **Job No.** 21-1234.23
Date 04/12/2021 **Time** 19:11
Location South Side, SW Section above Garage, 1st Ring of Column
Equipment Exterior Wall

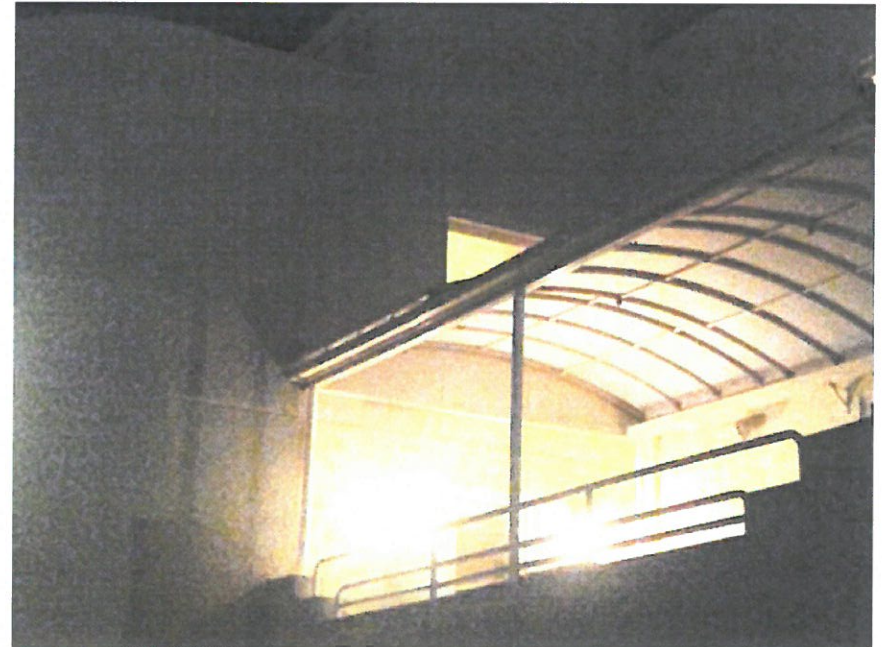
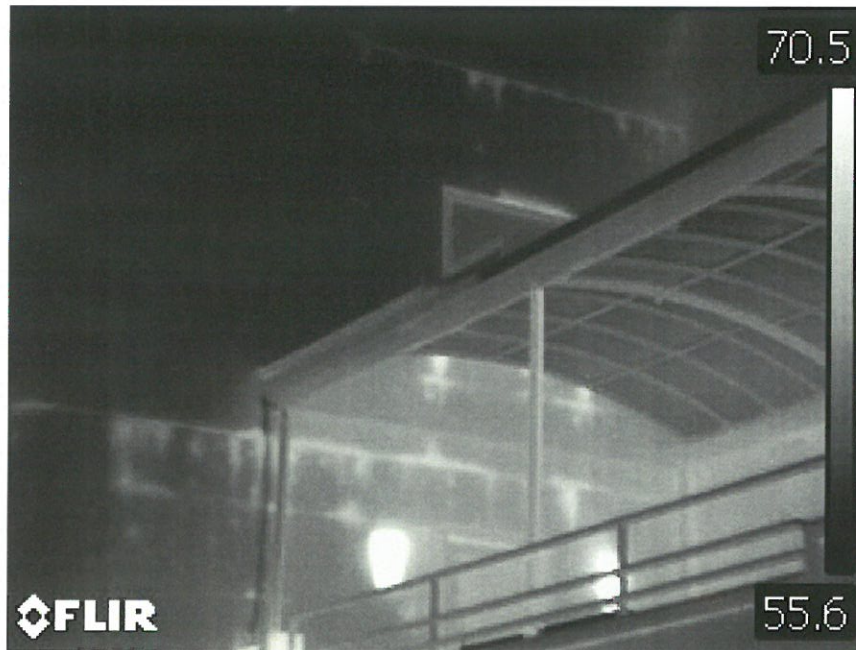
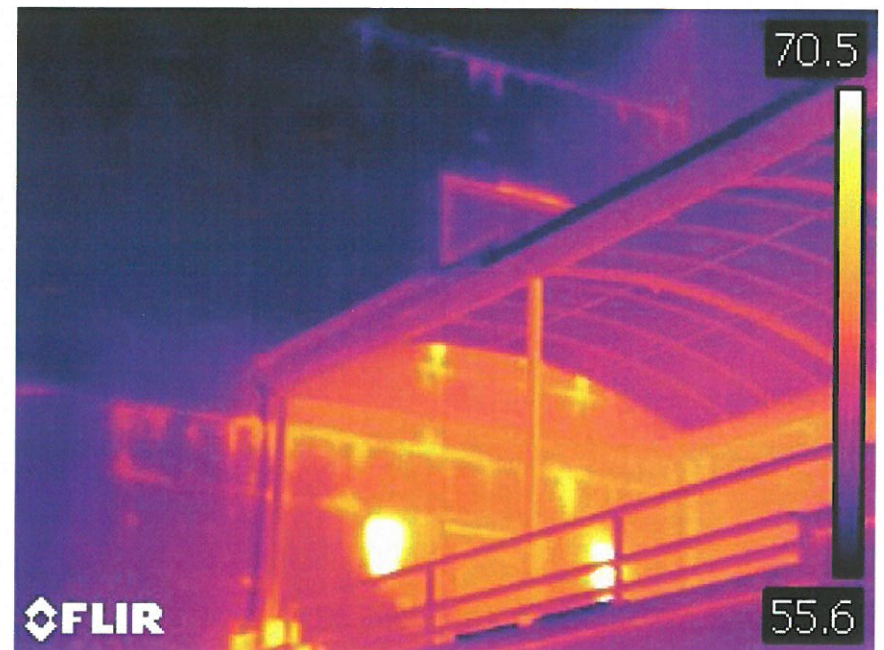
Area/Image No. 10 **Job No.** 21-1234.23
Date 04/12/2021 **Time** 19:14
Location West Side, Seam between 2nd & 3rd Floor, above Garage Balcony
Equipment Exterior Wall

Comments:
Area below 2nd Floor and above Garage Balcony Doorway

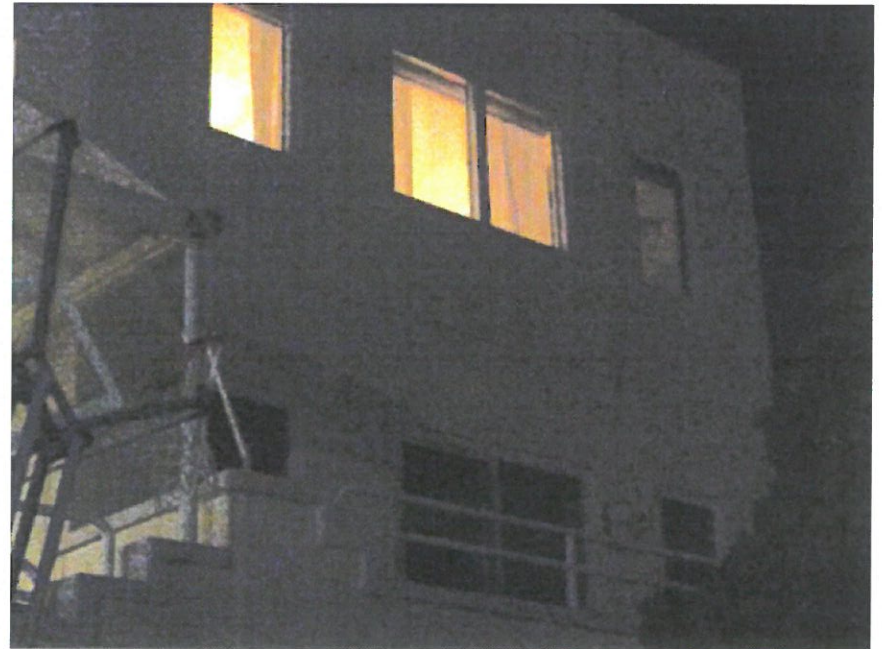
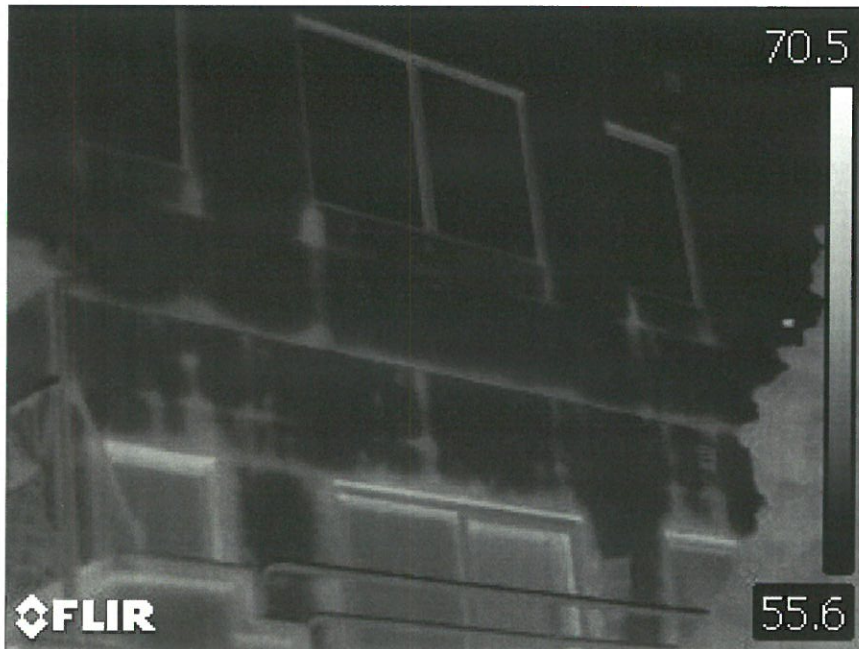
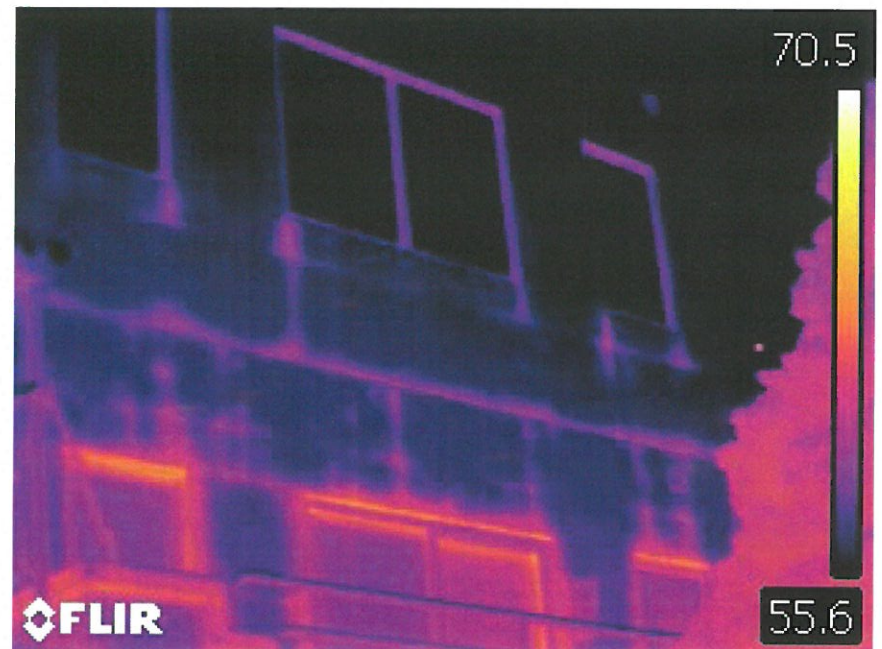
Area/Image No. 11 **Job No.** 21-1234.23
Date 04/12/2021 **Time** 19:16
Location West Side, between 2nd & 3rd Floor Windows above Rear Balcony
Equipment Exterior Wall

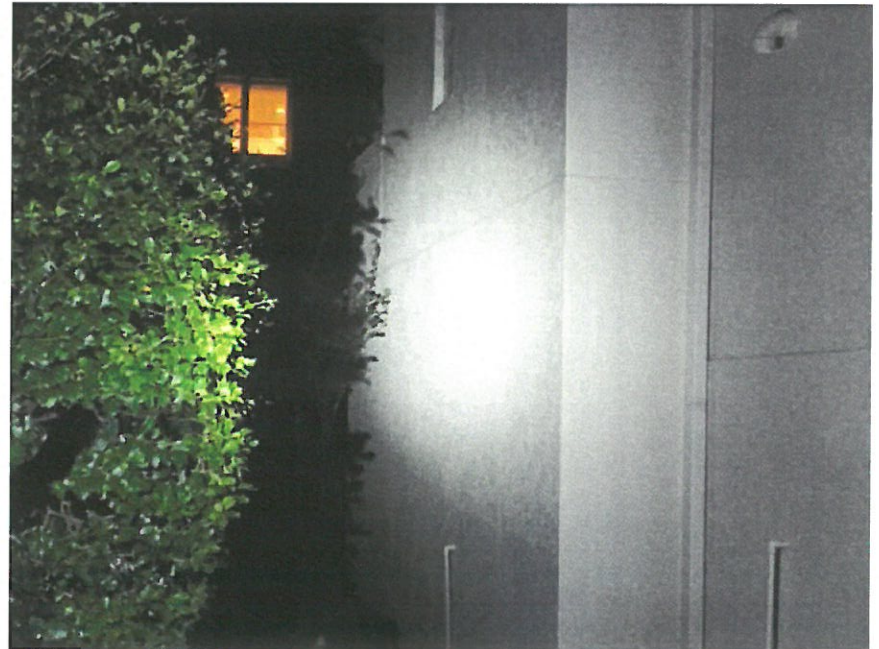
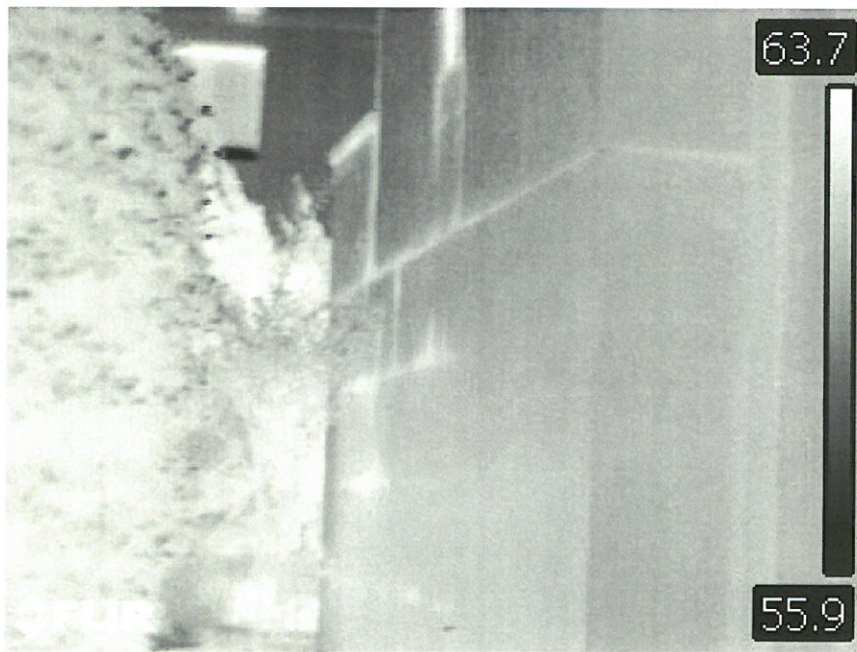
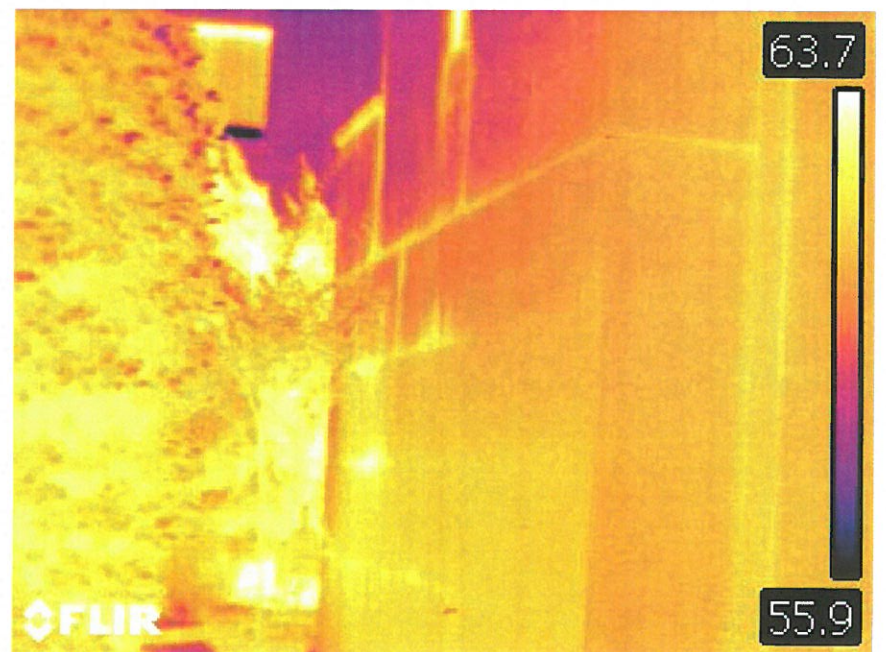
Area/Image No. 12 **Job No.** 21-1234.23
Date 04/12/2021 **Time** 19:18
Location North Side, NW Section below 1st Floor Window
Equipment Exterior Wall

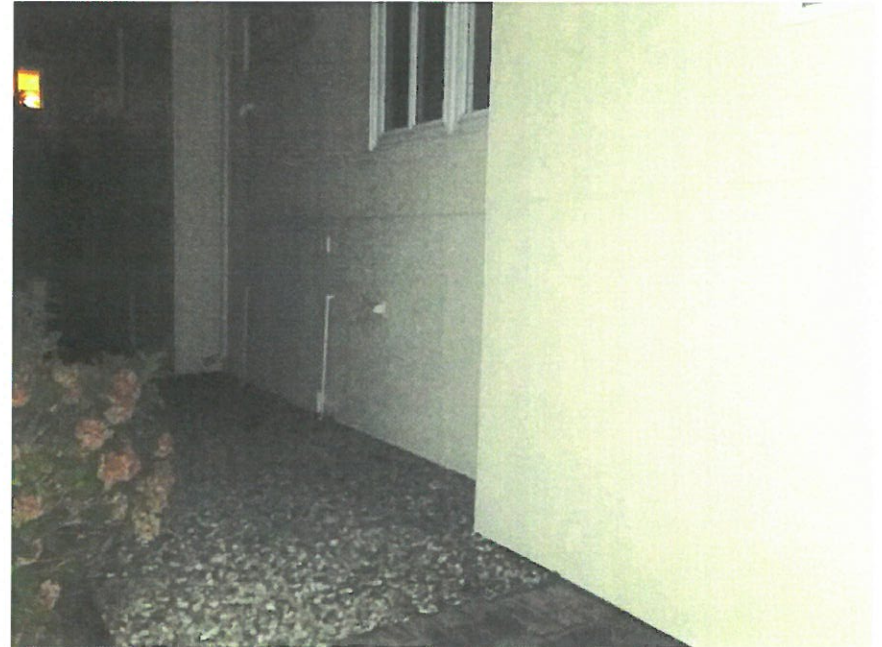
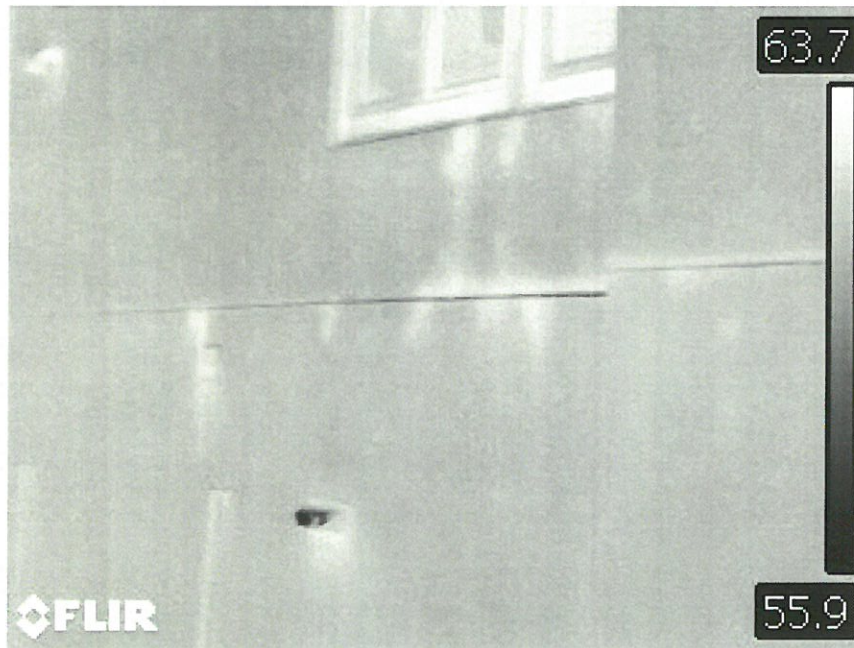
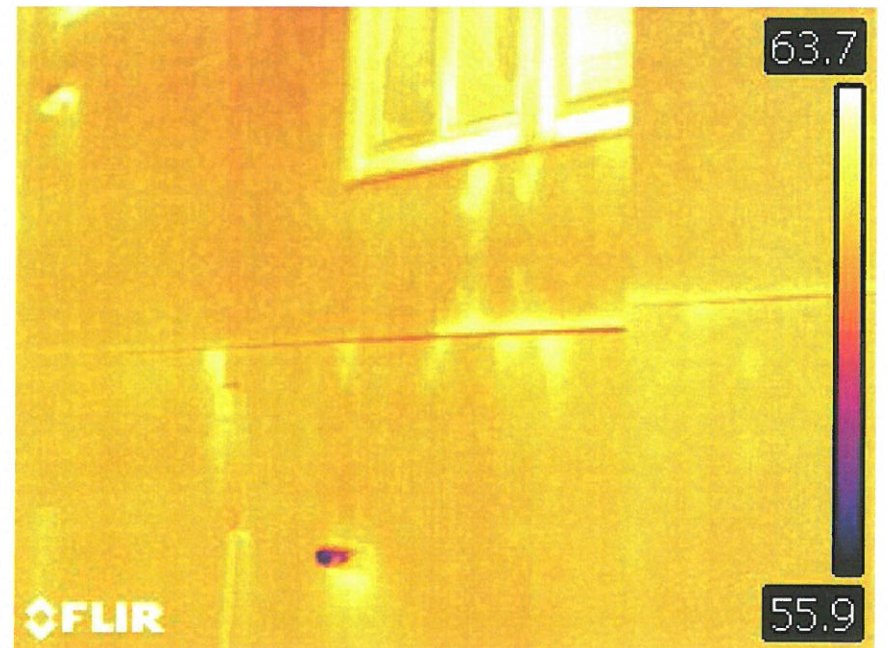
Area/Image No. 13 **Job No.** 21-1234.23
Date 04/12/2021 **Time** 19:19
Location North Side, along Seam below 1st Floor Window Center Section
Equipment Exterior Wall
