Infrared Inspection Report

ACME Manufacturing Company
100 Main Street
My Town, Any State 00000

Shamrock Sheet Metal Corporation
6789 Old Bridge Road
Montclair, NJ 07042

RE: INFRARED BUILDING ENVELOPE SURVEY REPORT
OUR JOB NUMBER: 21-1234.23

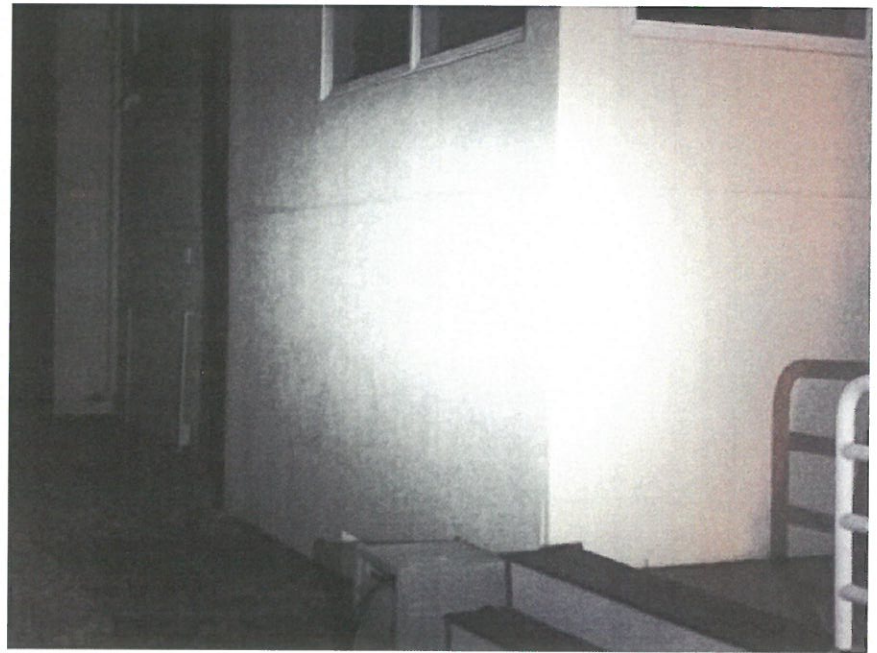
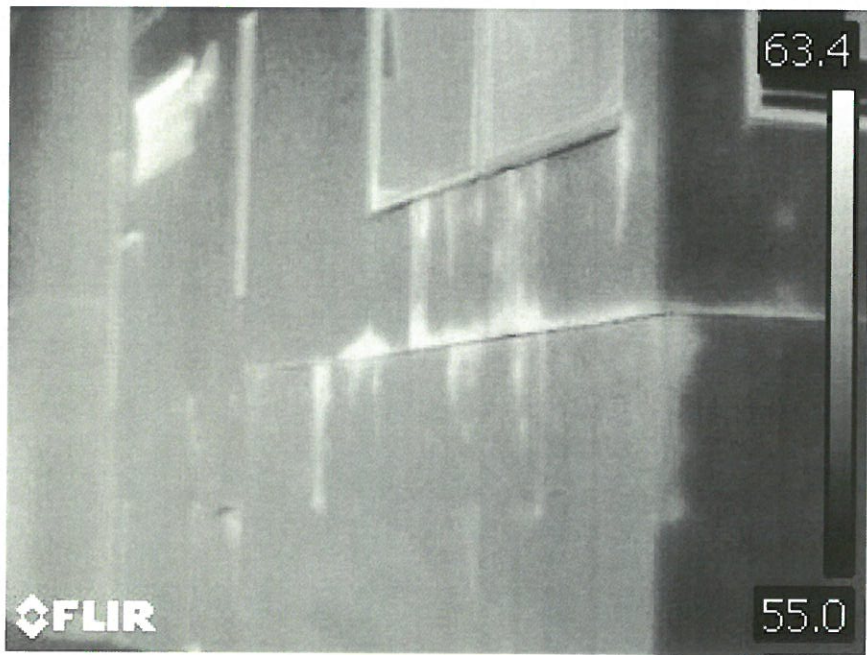
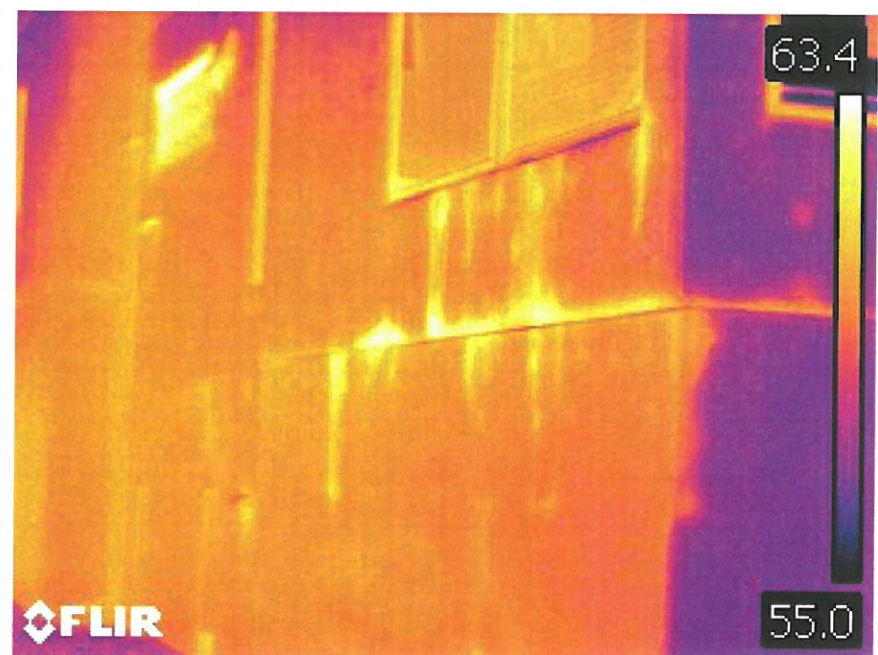
Area/Image No. 14 **Job No.** 21-1234.23
Date 04/12/2021 **Time** 19:30
Location North Side, NE Section below 1st Floor Window
Equipment Exterior Wall
